Office of Bridges and Structures

Emergency Response Manual for Over Height Collisions to Bridges

Issue Date: September 11, 2014

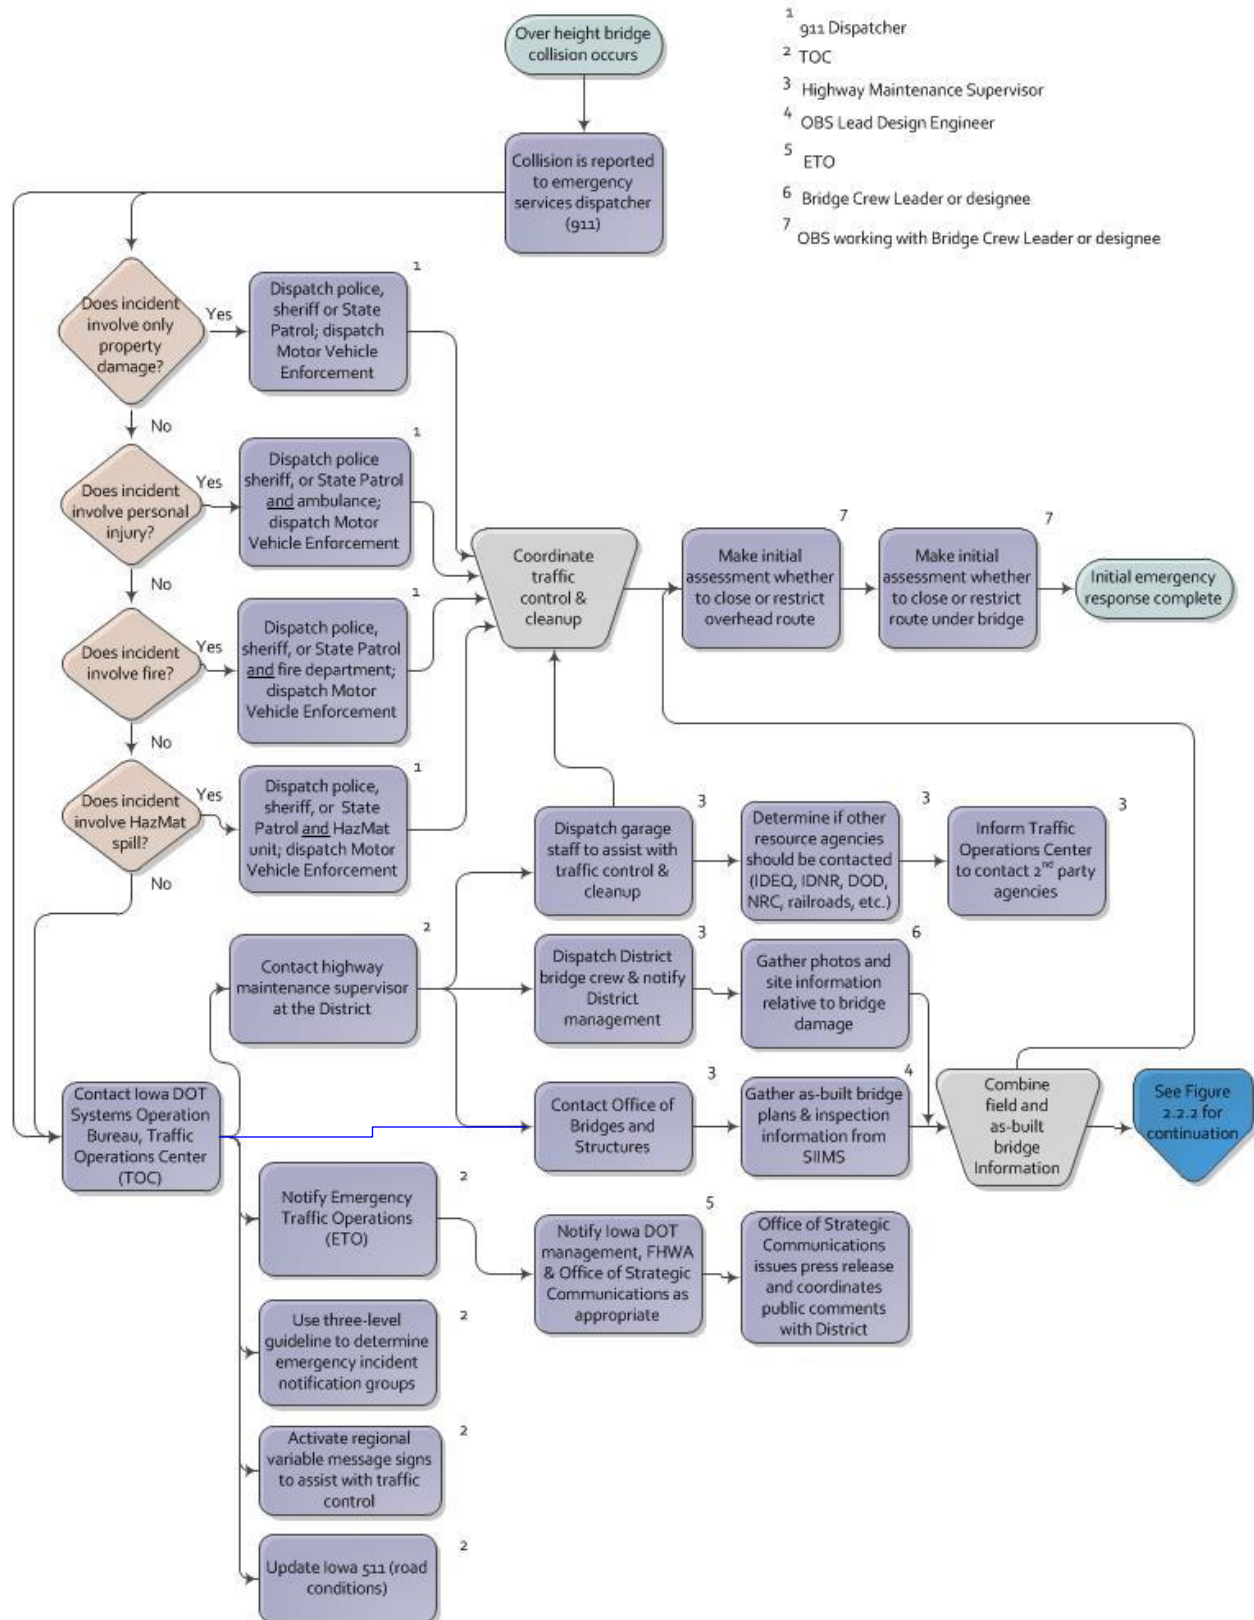
Figure 2.2-1. Initial Emergency Response Flow Chart

Three flowcharts presented in this section of the manual outline the emergency response procedures for an over height collision to a bridge. Figure 2.2-1 shows the procedures for the initial emergency response. This phase of the response is focused on addressing the immediate needs at the bridge site, including preserving life, minimizing injury, preserving public safety, minimizing hardship and suffering, restoring essential services, protecting property and the environment, and providing timely and accurate emergency communication to the public through media. The process outlined also addresses conducting an initial assessment of the damaged bridge based on as-built information available to OBS and information supplied by the on-site District Bridge Crew Leader or other authorized District staff as designated by the District Engineer or Assistant District Engineer.

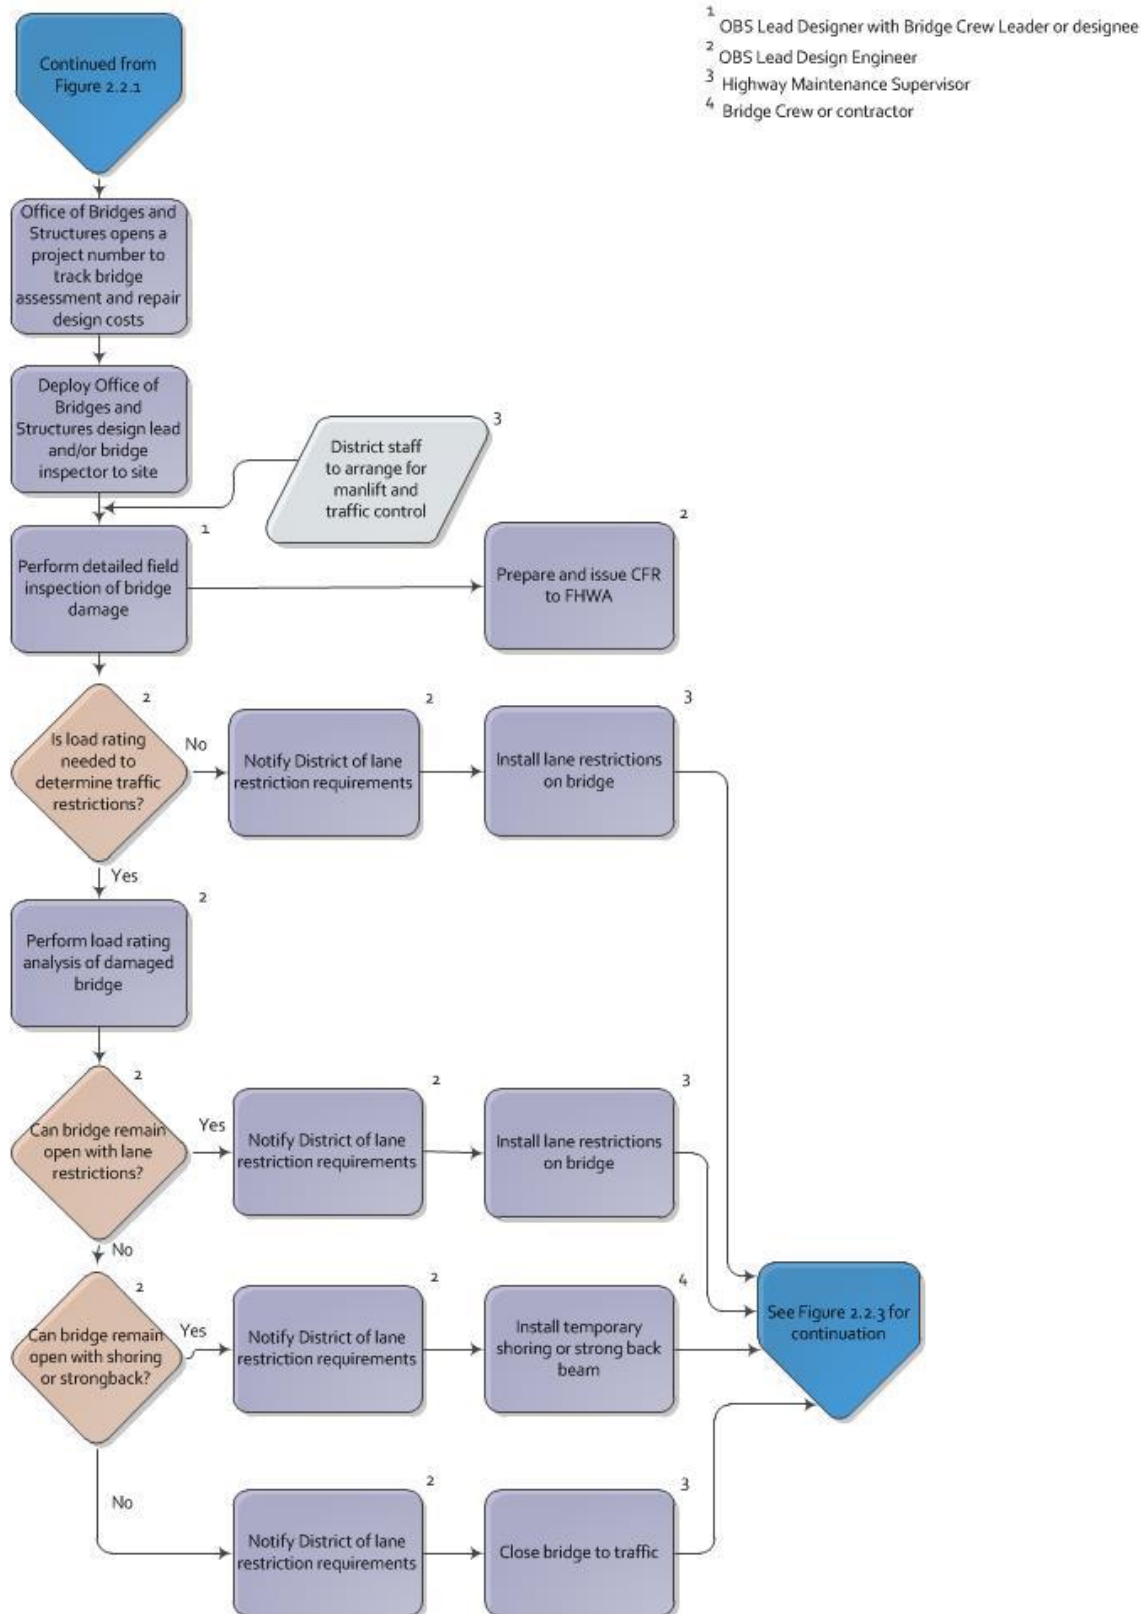
Figure 2.2-2. Detailed Bridge Assessment Flow Chart

The flowchart in Figure 2.2-2 addresses the steps to be taken to further assess the damaged bridge once the initial emergency is over. The procedures involve a detailed inspection of the bridge damage and a load rating analysis to determine whether the structure can remain in service while repairs are designed and prepared for contract. This assessment may result in the use of temporary measures to help support the bridge or it may result in a decision to close the bridge to traffic.

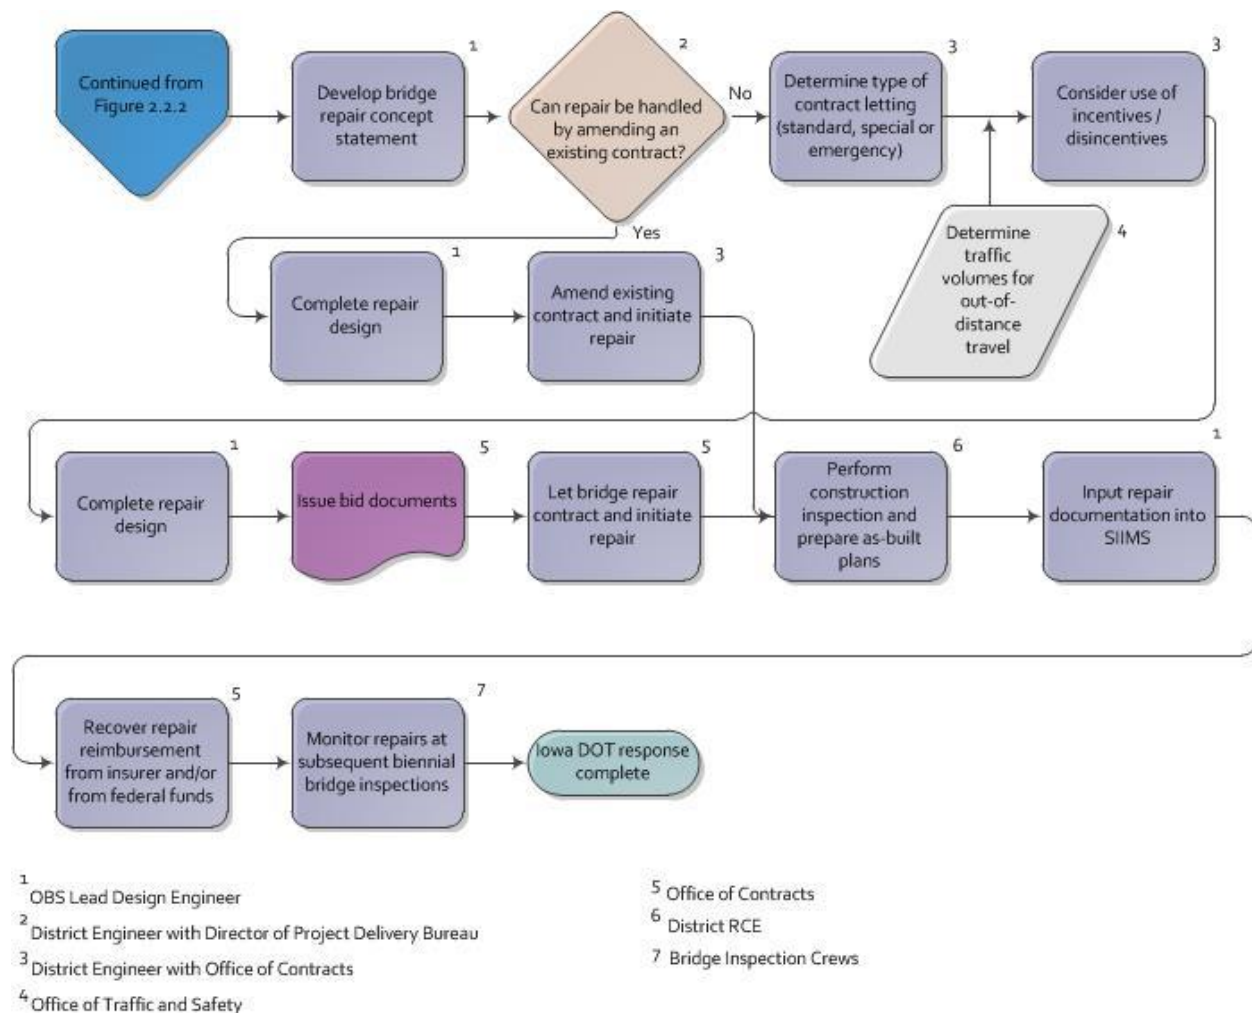
Figure 2.2-3. Repair Design and Contract Letting Flow Chart

Figure 2.2-3 shows the steps involved with designing repairs, preparing a contract letting for repairs, and completing the bridge repairs so that full traffic function and operation can be returned to the overhead route as well as the route below the bridge.

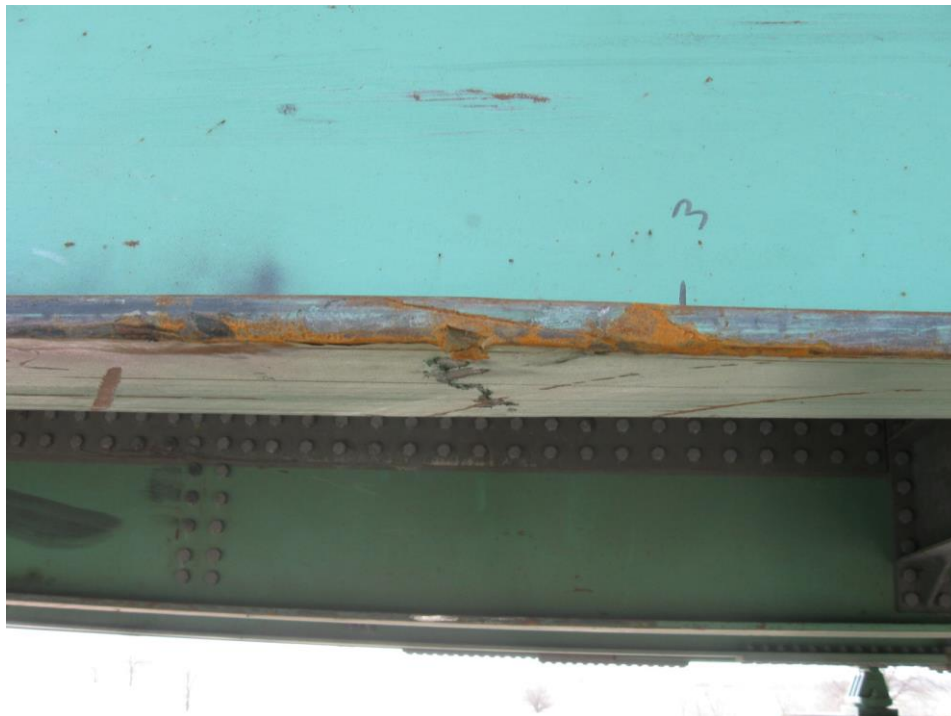
Figure 2.9.3.1-1. Steel Gouge and Paint Scrape

Figure 2.9.3.1-1 shows minor damage to a steel beam bridge consisting of paint scrapes and gouging of the bottom flange. Typically this type of damage should be repaired in a timely manner by removing the gouges by grinding as outlined in Section 3.5 of this manual. In most cases, the bridge may remain open without traffic restrictions if the gouging is not excessive.

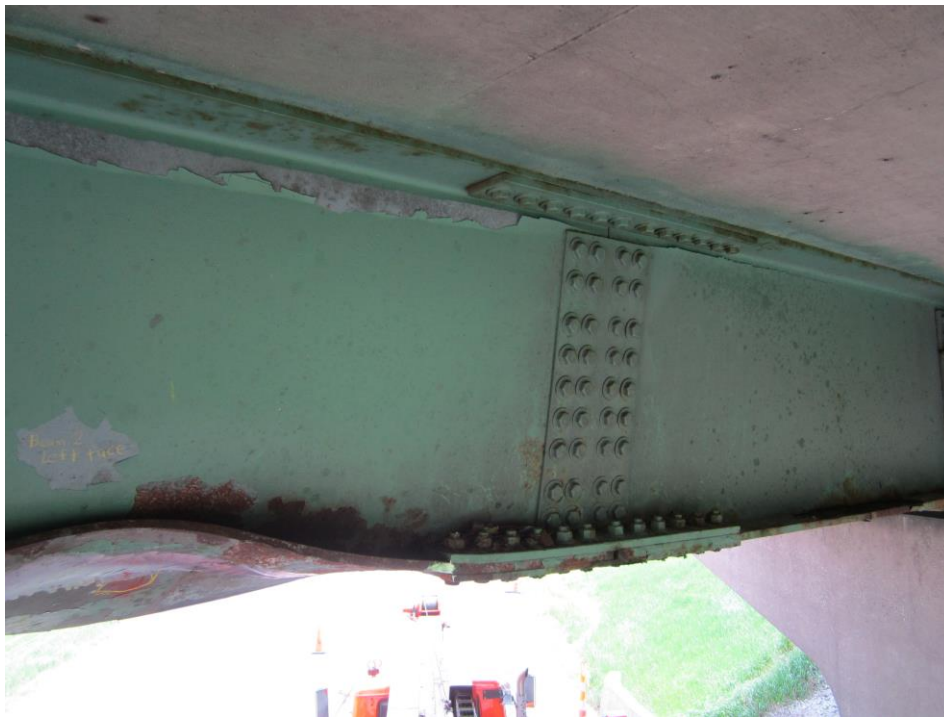
Figure 2.9.3.1-2. Moderately Bent Bottom Flange with Some Web Distortion

Figure 2.9.3.1-2 shows a moderately bent bottom flange with some web distortion. If this type of damage did not include any fractures or tears to the steel members and if the extent of the distortion was not too severe, often this type of damage would be repaired with heat straightening, which would combine controlled heat with some internal or external restraining forces to return the member to its original geometry. In general, heat straightening should only be used on the same damaged area of a beam for two heat straightening operations because of the tendency to reduce the ductility of the base metal with more than two heat straightening operations. Often heat straightening repair will require supplemental support of the steel beam during repair. In these cases, a strong back beam may be placed on the deck of the bridge to help support the damaged beam or temporary shoring towers may be employed during heat straightening operations.

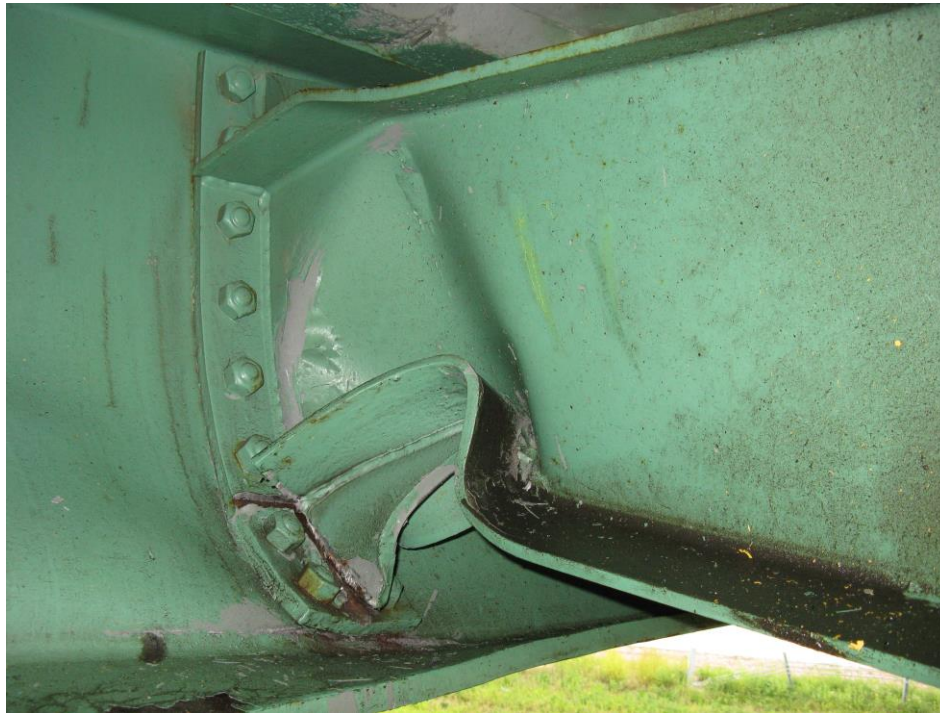
Figure 2.9.3.1-3. Damaged Diaphragm Member

Figure 2.9.3.1-3 shows a damaged and distorted diaphragm member. Although primary girder damage may need to be heat straightened or repaired by some other means, typically it is easiest to just replace damaged diaphragm members with the girder repairs rather than trying to repair or straighten them.

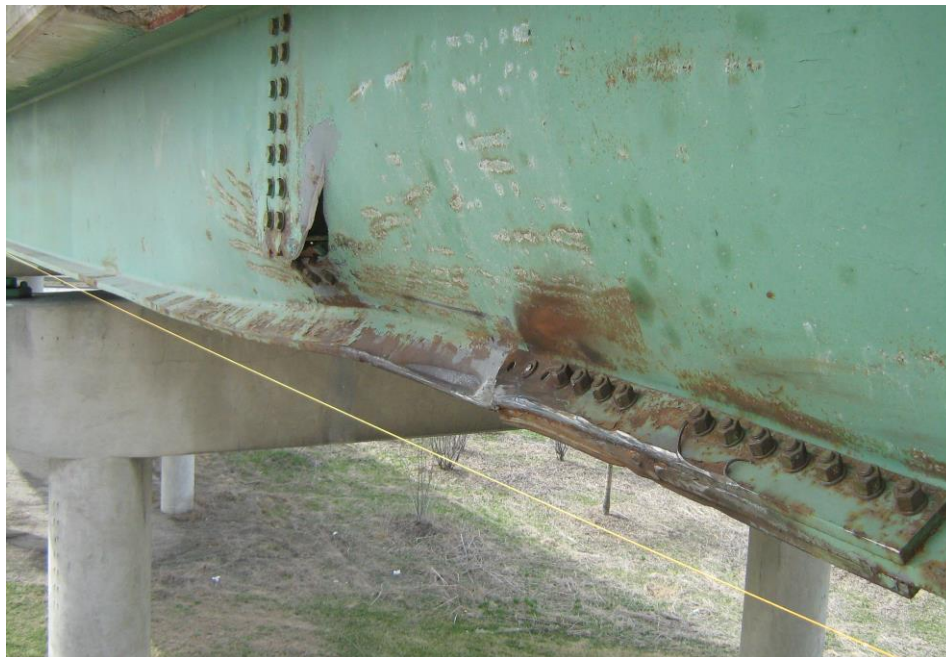
Figure 2.9.3.1-4. Out of Plane Bending with Web Tear

Figure 2.9.3.1-4 shows severe damage to an exterior beam line that has resulted in tearing and fracture of the steel beam. For this type of damage, often a strong back beam or temporary shoring towers would be used to support the damaged beam during repairs. Since the damage involves fracture to the beam, some level of beam replacement would be needed. One option would be to cut out and remove the bottom flange and the distorted and torn lower portion of the girder web between field splices and replace it in kind with a spliced section of web and a new bottom flange. Alternatively, if the damage also includes extensive cracking and spalling of the bridge deck, it may be necessary to remove portions of the deck above the damaged beam, remove and replace the entire steel beam between field splices, and replace the section of bridge deck that was removed.

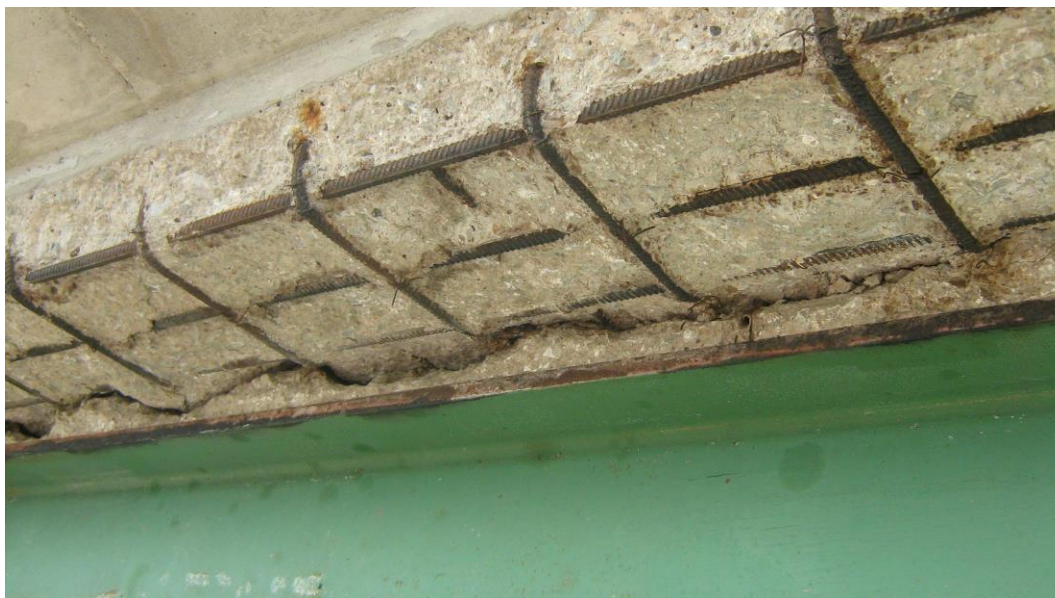
Figure 2.9.3.1-5. Bottom of Deck Spalling with Crack at Girder-to-Deck Interface

Figure 2.9.3.1-5 shows spalling to the underside of the bridge deck in the cantilevered section of the deck and cracking along the interface between the top flange of the steel beam and the bottom of the bridge deck. If no surface spalling to the top surface of the bridge deck is involved, a possible repair would be to epoxy inject the crack at the top flange/bottom of bridge deck interface and then repair the spall damage to the underside of the bridge deck. If extensive damage in the form of either cracking or spalling has occurred at the top surface of the deck, removal and replacement of a portion of the bridge deck may be needed.

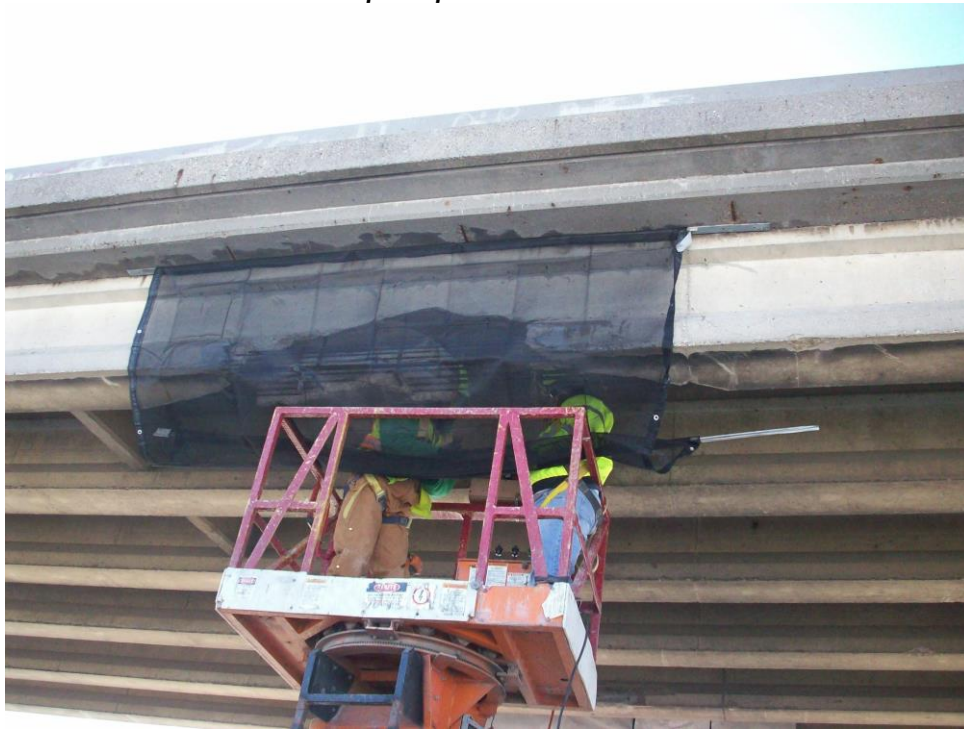
Figure 2.9.3.2-1. Installation of Drape to Catch Loose Debris

Over height vehicle damage to prestressed concrete beam bridges inevitably results in some degree of concrete spalling with loose concrete that could provide a hazard to traffic below. Figure 2.9.3.2-1 shows a typical drape that would be used to catch loose debris.

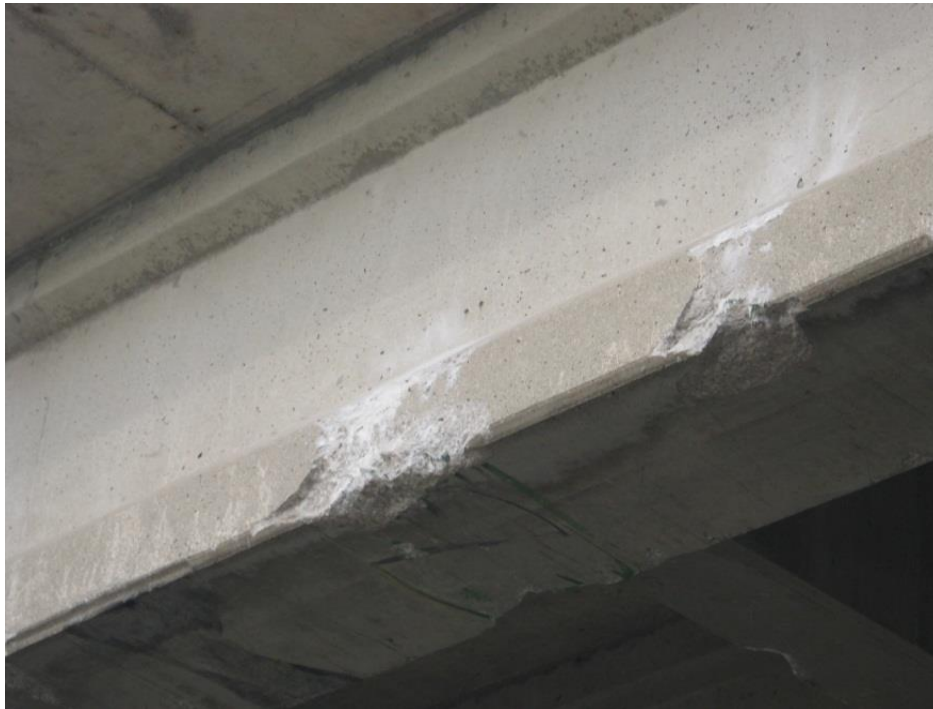
Figure 2.9.3.2-2. Minor Bottom Flange Spalling

Figure 2.9.3.2-2 depicts typical minor spalling that may occur along the bottom flange of a prestressed concrete beam. In a case such as this, no mild reinforcing steel or prestressing strands have been exposed or damaged. Iowa DOT does not typically patch this type of damage to restore the original cross section of the beam due to the potential for the patch to come loose and drop on traffic. However, it is recommended to seal these types of spalls with a grey paint-type sealer in order to better identify any future hits to the same area.

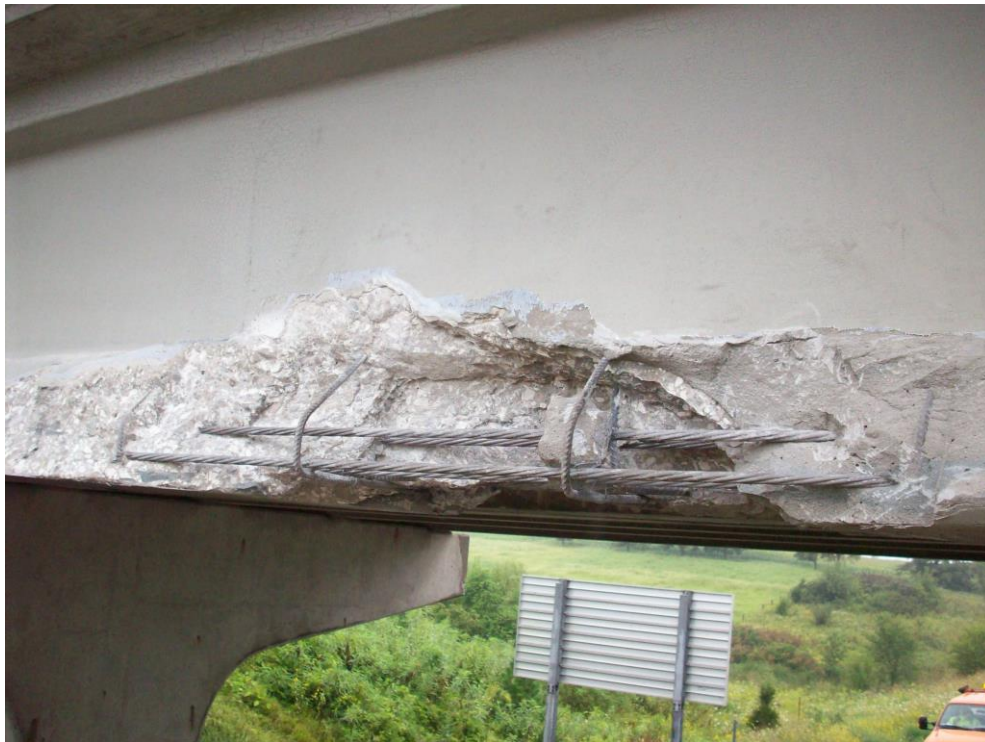
Figure 2.9.3.2-3. Bottom Flange Damage with Mild Reinforcing and Prestressing Strands Intact

As impact damage to a prestressed concrete beam bridge becomes more substantial, it can be expected that larger spalls may occur, often exposing mild reinforcing steel or prestressing strands as shown in Figure 2.9.3.2-3. Iowa DOT employs a few repair strategies for these types of damage to restore the damaged beam to its original properties.

One such repair would involve first patching the spalls to return the beam to its original cross section. Often, following spall repair, a FRP wrap would be placed around the bottom flange of the beam in the damaged area and up the sides of the beam web. The FRP wrap can provide added shear strength to the beam, but generally it also serves to confine and contain the spall repairs to prevent them from separating from the beam and falling onto traffic below.

A second repair strategy, and one that is often employed for exterior beams that may be subjected to repeated impacts by over height vehicles, is to repair the spalled areas, but then encase the bottom of the beam with a two-piece steel sleeve. The steel sleeve is anchored with concrete anchors into the beam and then the space between the concrete beam and the inside of the steel sleeve would be injected with epoxy to bind the sleeve to the concrete beam. The steel sleeve serves to armor the bottom of the beam and thus provide a greater degree of protection from future vehicle strikes.

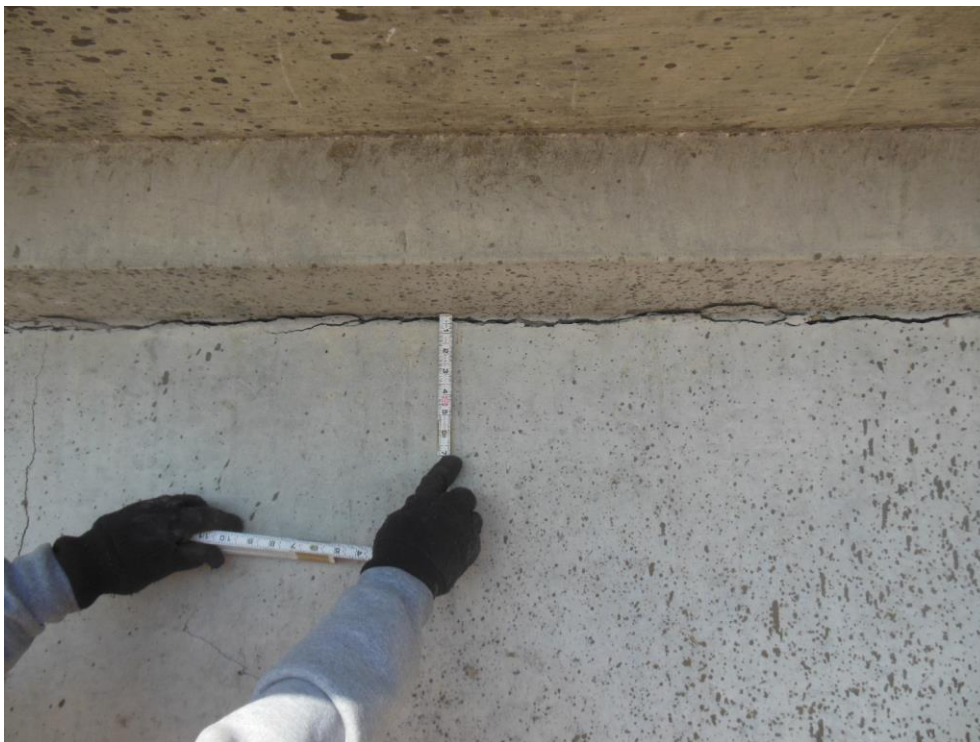
Figure 2.9.3.2-4. Cracking Along Web-to-Top Flange Interface

Over height vehicle impacts to prestressed concrete beam bridges may be severe enough to initiate displacement of a concrete beam. Often when the beam tries to displace, a crack may form at the interface of the beam web with the top flange of the beam as show in Figure 2.9.3.2-4. With this type of damage, the inspector should look at the top of bridge deck to determine if any cracking or spalling has occurred in the actual bridge deck. If not, and if the cracking is limited to the interface between the beam web and the top flange, or possibly the interface of the top of the beam and the bottom of the bridge deck, the crack can be epoxy injected to seal the crack from moisture intrusion. Other web cracking in the beam may be evident, such as diagonal cracking in the web that radiates downward from the terminus of the web-to-top-flange crack. These web cracks should also be epoxy injected to seal the cracks from moisture intrusion.

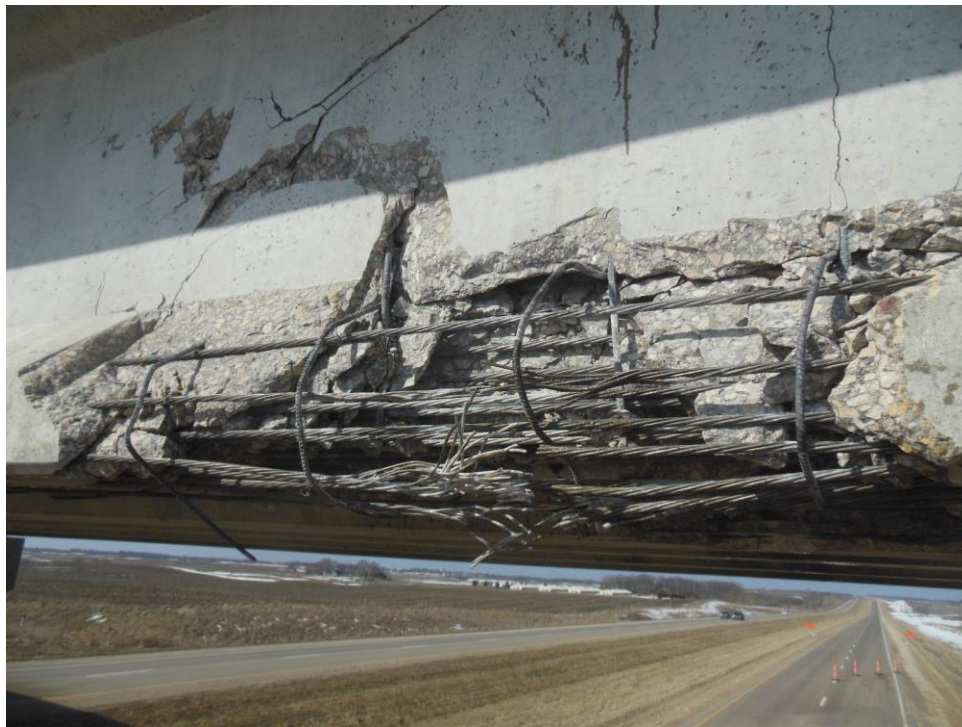
Figure 2.9.3.2-5. Heavy Damage with Web Cracking and Severed Mild Reinforcing and Prestressing Strands

Generally, the most severe damage to prestressed concrete beam bridges involves extensive spalls and girder cracking that severs mild reinforcing steel and prestressing strands as shown in Figure 2.9.3.2-5. If beam damage involves severing of two or more prestressing strands, a possible temporary repair alternative may involve patching of the beam spalls, epoxy grouting beam cracks, and either splicing the severed prestressing strands or supplementing the damaged strands with external prestressing. However, these types of repairs should only be considered temporary until the beam or the entire bridge can be replaced.

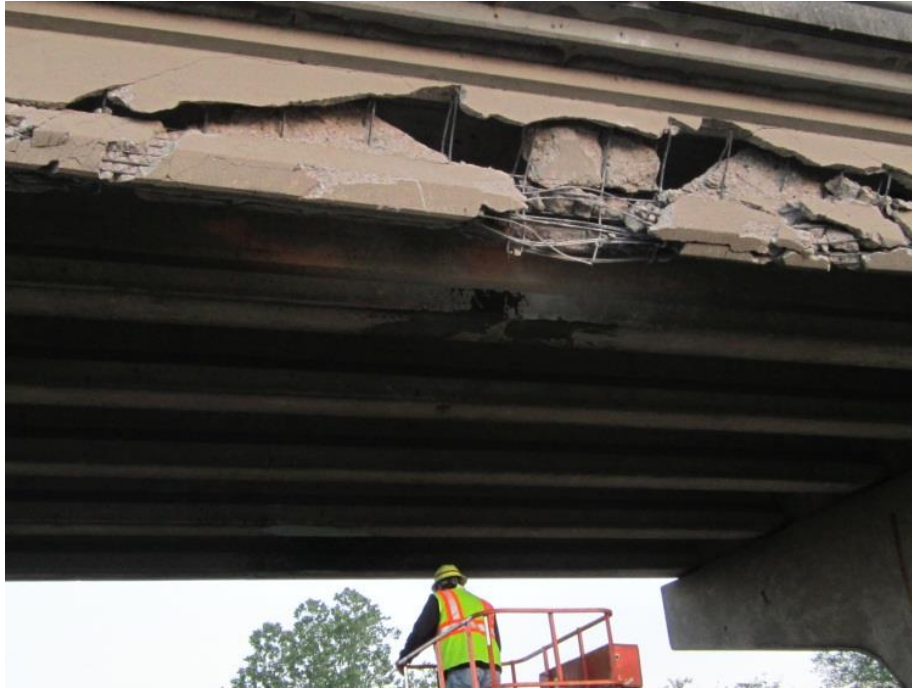
Figure 2.9.3.2-6. Severe Prestressed Beam Damage with Excessive Concrete Section Loss

Severe damage to prestressed concrete beam bridges might also involve excessive loss of concrete section as shown in Figure 2.9.3.2.6 or severe damage to multiple beams as shown in Figure 2.9.3.2.7. In most of these cases, the extents of the prestressed beam and bridge deck damage is so severe that removal of the bridge deck above the damaged beam and replacement of the beam is warranted or total span replacement is needed.

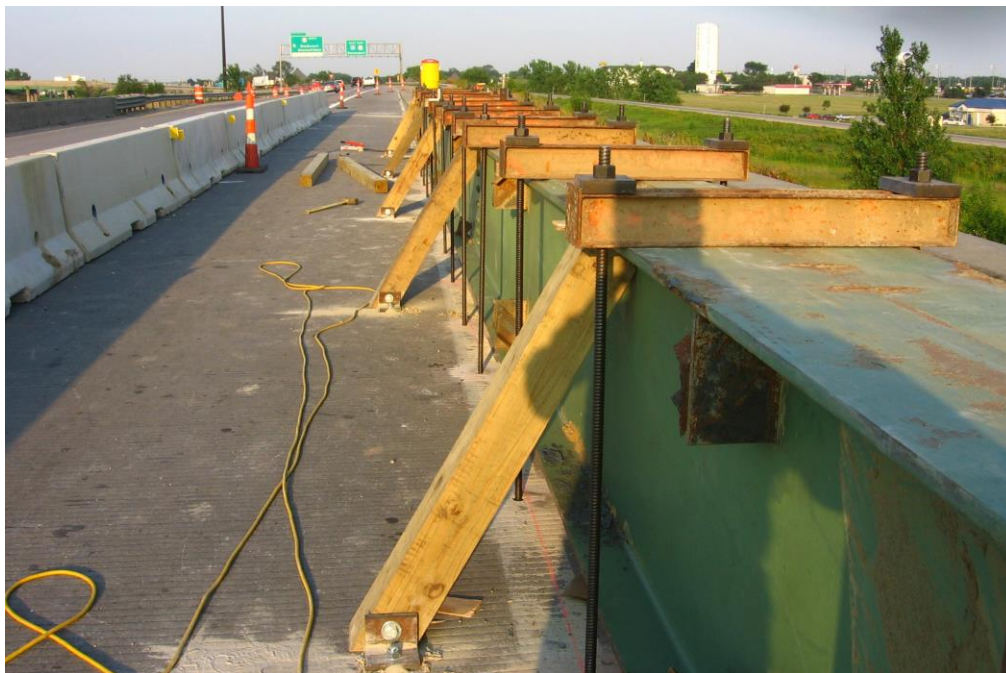
Figure 3.1. Temporary Strong Back Beam

Over height vehicle collisions to steel beam or steel plate girder bridges may result in damage to the steel beams or girders that may compromise the load carrying capacity of the bridge. This may be due to steel members being torn or members being severely bent such that the strong axis moment of inertia is compromised. In these cases, it may be necessary to install a temporary strong back member to provide supplemental support to relieve load from the damaged member(s). An example of a temporary strong back beam in use is shown in Figure 3.1

Iowa DOT has two steel beam components in storage that can be bolted together to provide auxiliary strong back support to a damaged steel beam. The 58-foot-long and 45-foot-long strong back beam components typically would be bolted together and supported on top of a bridge deck of a damaged steel beam/girder bridge to provide auxiliary support for a damaged beam/girder. With the strong back beam supported on timber cribbing near pier locations, threaded rods would be extended through holes in the bridge deck and connected to a secondary member under the deck. By tightening the hanger rods, load would be incrementally relieved from the damaged beam until the damaged beam/girder is supported adequately by the strong back beam. Then, repairs such as heat straightening or cutting out and replacing damaged portions of the beam could be made to the damaged beam.

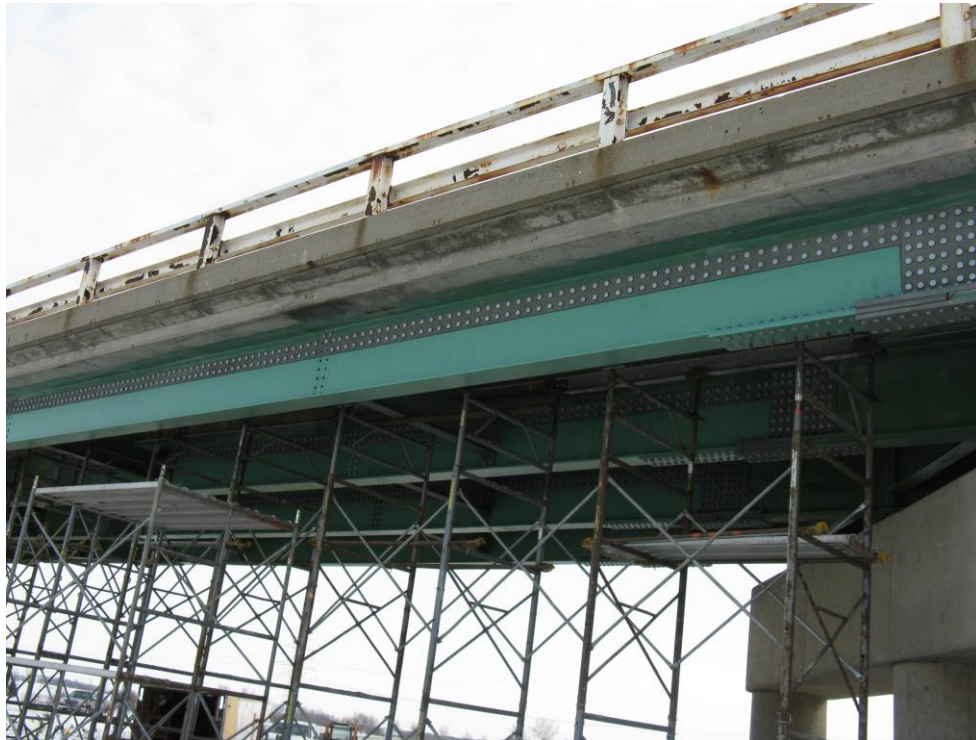
Figure 3.2. Partial Steel Beam Removal and Replacement

A photograph of a completed steel beam removal and replacement is shown in Figure 3.2.

For the longitudinal web splice depicted in Figure 3.2 that connects the existing top and the new bottom portions of the beam web, the spacing of 7/8-inch diameter A325 bolts in double shear was analyzed to satisfy horizontal shear of the beam at various locations. Iowa Department of Transportation English Bridge Standards (40-foot Roadways – 3 Span Rolled Steel Beam Bridges) were used for all sectional and geometrical properties in the analysis. Only the center span between field splices (that is, positive moment region) of each bridge was considered, as this is the most likely location that a steel beam would be damaged from traffic below. Minimum and maximum conditions were examined to develop an envelope of possible bolt spacings. The minimum condition examined was a minimum standard bridge length of 160 feet, which carried a 64-foot center span. The maximum condition examined was a 240-foot standard bridge length, which carried a 96-foot center span. This span length was deemed the maximum length for which Iowa DOT's 103-foot-long strong back beam could be utilized.

Once a strong back beam or shoring towers are in place to provide auxiliary support, often a guide angle is bolted to the web of the damaged beam to provide a straight guide surface to provide a uniform cut line for the girder web. Generally, the portion of beam removed will often extend between existing field splices. Since some areas of distortion may still remain in the portion of the girder web that remains, cold jacking against an adjacent beam line may be required to return distorted portions of the web that remains to a straight, uniform alignment. Continuous web splice plates are then bolted in place to connect the web of the existing beam with the new replacement web. In addition, the web and bottom flange are fully bolted into place at field splices. Typically, this type of repair will require replacement of damaged diaphragm members that fall within the impact zone.

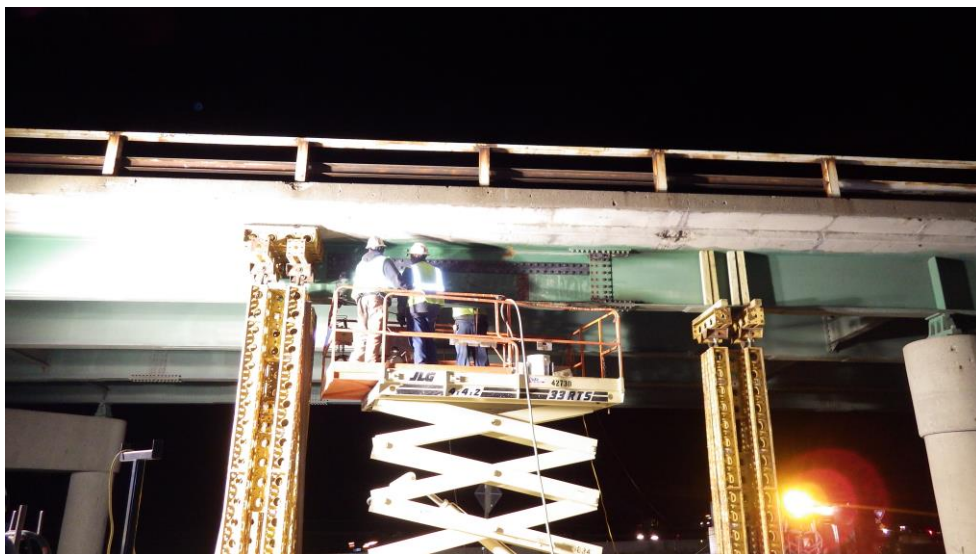
Figure 3.4-1. Shoring Towers on Each Side of Damage

Figure 3.4.1 shows two shoring towers that have been placed on either side of the damaged section of the exterior beam line, thus shortening the distance that the damaged beam must span and reducing the bending moment. In this particular case, the lower portion of the damaged steel beam (that is, bottom flange and lower half of the web) were removed between the towers and replaced with a new section of beam.

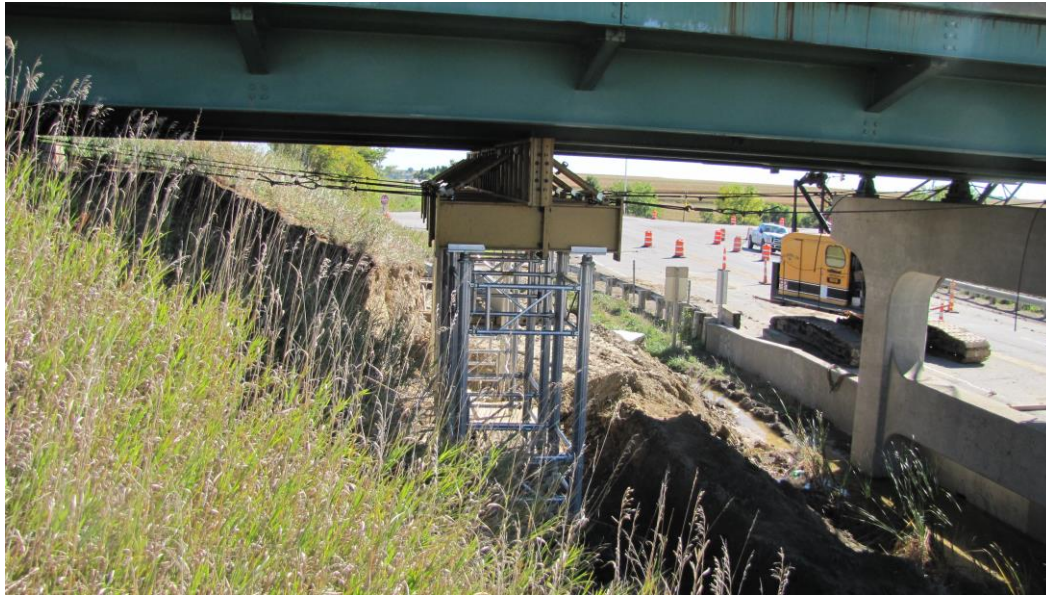
Figure 3.4-2. Shoring Tower Providing End Span Support

Figure 3.4-2 shows a shoring tower placed to support the end span of a three-span continuous steel beam bridge. In this particular case, a portion of the bridge deck in the damaged center span had to be removed to allow total replacement of the positive moment field sections for several damaged beam lines.

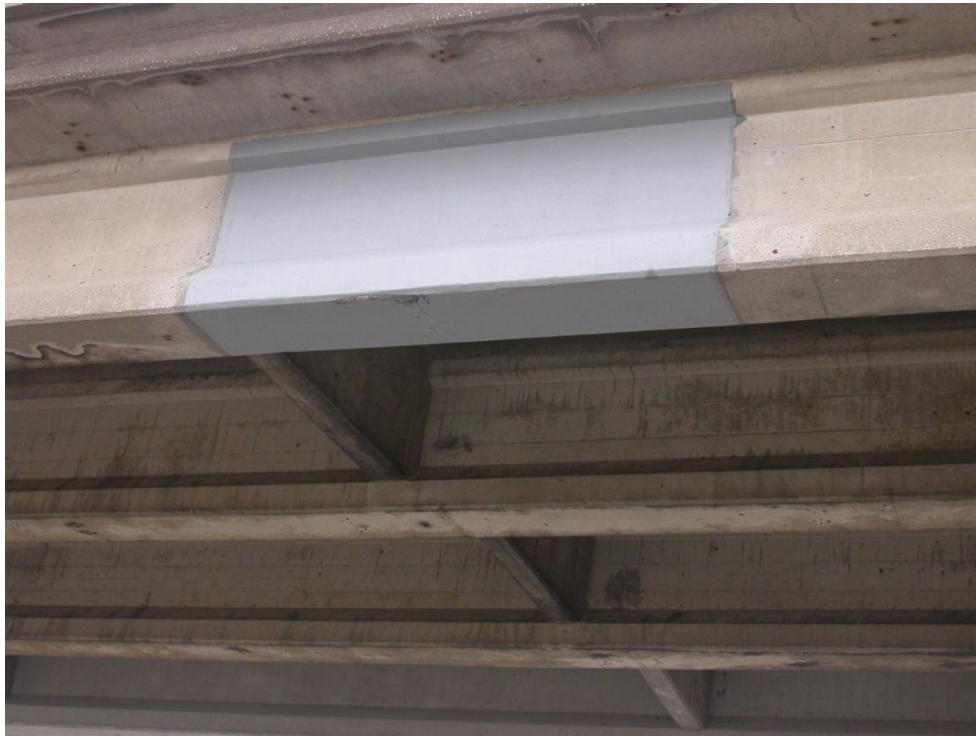
Figure 4.2. Fiber Reinforced Polymer Wrapped Repair

Carbon fiber and FRP wraps are commonly used to help contain damage to prestressed concrete beams and to restore structural integrity to the damaged beam(s). An example of an in-place FRP-wrapped repair for a prestressed concrete beam is shown in Figure 4.2.

Typically, for prestressed concrete beams that have been damaged by an over height vehicle collision, repairs begin with removing any unsound concrete around the spalled area of the beam followed by preparing and cleaning the concrete surface at the repair area. Care should be taken to prevent additional damage to surrounding concrete, mild reinforcing steel, or prestressing strands. The limits of the repair area should be defined with a 0.75-inch-deep saw cut to prevent feathered edges of repair, and loose concrete around mild reinforcing steel and prestressing strands should be removed to provide 0.75-inch exposure all around. Next, the damaged area of the beam is repaired with Class “O” Structural Concrete.

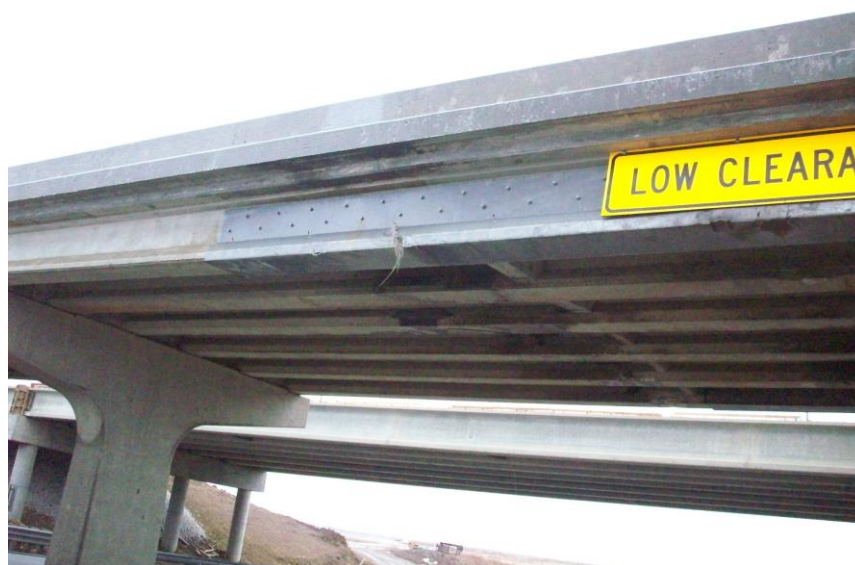
Figure 4.3. Grouted Steel Sleeve Repair

Another repair technique used for damaged prestressed concrete beams is to install a steel sleeve around the damaged bottom flange of a prestressed concrete beam and inject epoxy resin into the space between the sleeve and the face of the prestressed concrete beam. This type of repair is depicted in Figure 4.3.

For this type of repair, unsound concrete is removed from the spalled area, the area to be restored is cleaned, and the surface is prepared. Care should be taken to prevent additional damage to surrounding concrete, mild reinforcing steel, or prestressing strands. The limits of the repair area should be defined with a 0.75-inch-deep saw cut to prevent feathered edges of repair, and loose concrete around mild reinforcing steel and prestressing strands should be removed to provide 0.75-inch exposure all around.

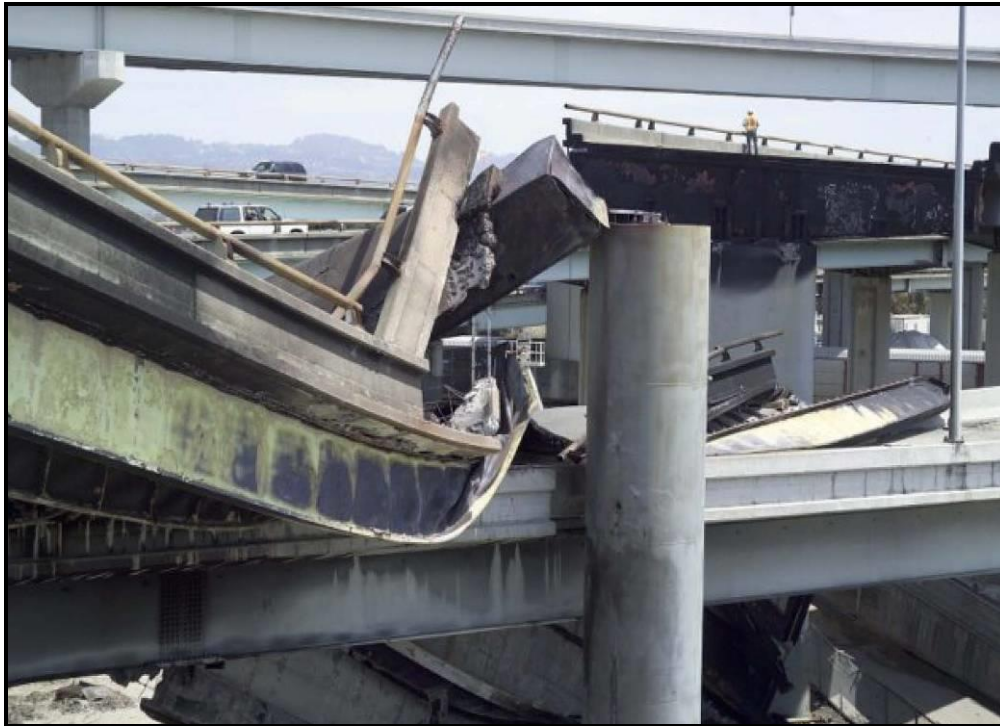
Figure 5.1.1. Collapse of I-880 Bridge in San Francisco from Fire Damage

Steel girders subject to the intense heat of a tanker fire could sustain damage or deform/deflect due to the heat. Structural steel typically will show only a gradual decrease in yield strength for temperatures up to approximately 500°C (932°F). However, at approximately 600°C (1,112°F), the yield strength of steel will be reduced to approximately 50 percent of its nominal yield strength. Steel also undergoes a phase transformation above approximately 725°C (1,337°F), where the grain structure may change through heating and cooling. Heat cambering and heat straightening operations typically limit the temperature of steel to below 650°C (1,202°F) so that the steel does not experience conditions worse than what it might see during a typical fabrication process. Steel heated to below the phase transformation stage and then cooled will return to its previous properties without detrimental long-term reduction in yield strength, toughness, or fatigue resistance. However, even though a steel member may return to its original properties after a fire, the member may undergo distortion, may sag, or may experience rapid thermal expansion during the fire due to the intense heat. During a fire, the temperature of a steel girder may be substantially below the maximum gas temperature of the actual fire. The bridge deck may be at an even lower temperature because of its added distance from the heat source and the lower thermal conductivity of concrete. A composite steel girder bridge exposed to intense heat from fire is susceptible to web buckling because the cooler composite deck would impose restraint to the top of the girder while the bottom of the girder is attempting to expand.

Figure 5.1.1. depicts the collapse of a steel girder bridge due to the temporary reduction in steel strength during an intense fire.
