Office of Bridges and Structures

Emergency Response Manual for Over Height Collisions to Bridges

Issue Date: September 11, 2014

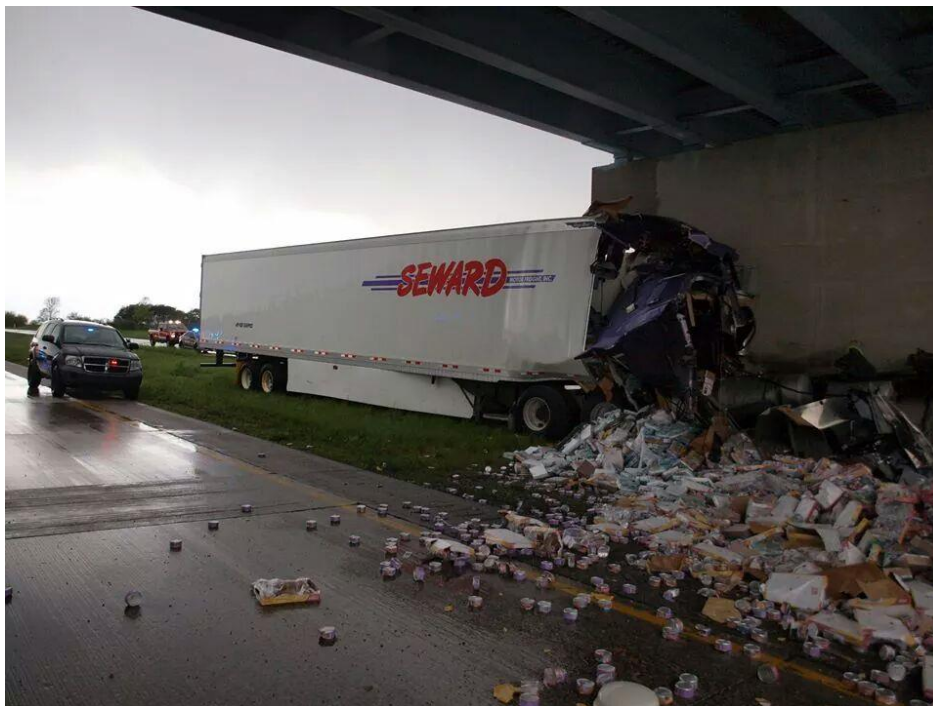
Figure 5.1.2. Truck Collision with Bridge Pier

As is evident in Figure 5.1.2 below, this type of incident could trigger a similar type of emergency response as an over height collision, requiring lane closures for accident clean-up and emergency personnel, the need to inspect the bridge for damage, and potentially the need to stabilize or repair the bridge for carrying traffic loads.

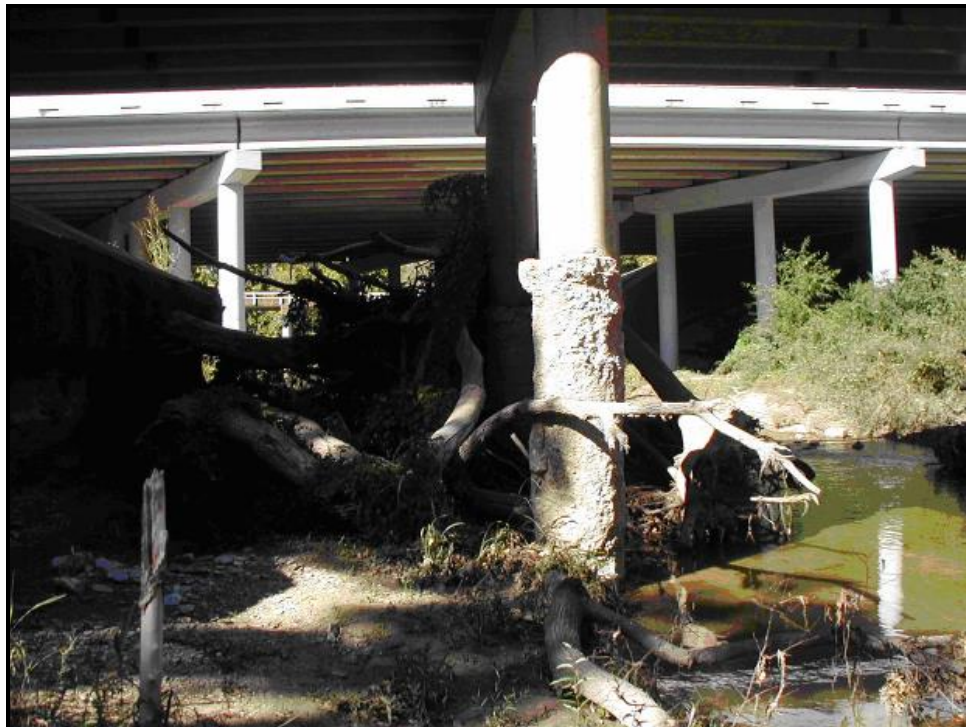
Figure 5.1.4. Bridge Pier Scour Damage

However, a significant flood event could cause major scour to a bridge with little advance notice. A post-event inspection or signs of settlement could require emergency corrective action and thus require an emergency response for a critical route similar to an over height collision event. Figure 5.1.4. shows an example of a bridge affected by flood scour.

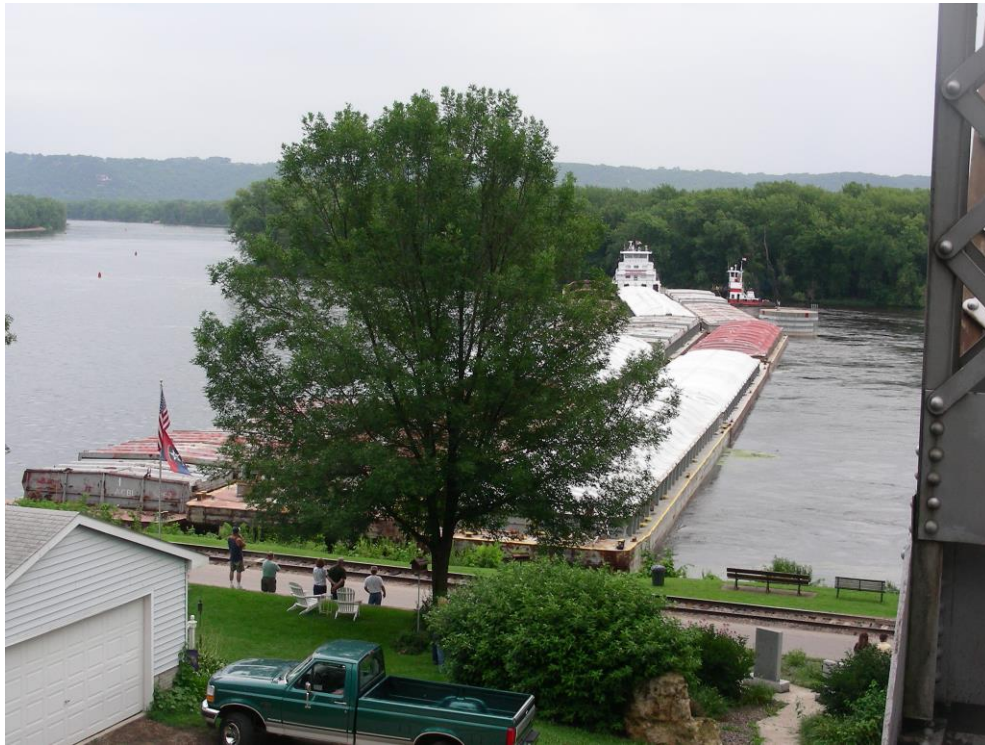
**Figure 5.1.5. Barge Lodged Across the Mississippi River Channel
Parallel to IA-9 Lansing Bridge**

With major bridge structures located over navigable rivers such as the Mississippi and Missouri rivers, there is potential for damage to highway bridges in Iowa due to barge impact. Most, if not all, of the bridges carrying State and U.S. routes over these rivers are high-level structures with adequate vertical clearance to protect bridge superstructures from a barge impact. Nevertheless, the potential for damage to a bridge due to impact with a substructure component is very real, as shown in Figure 5.1.5 for the IA-9 Bridge over the Mississippi River near Lansing, Iowa.

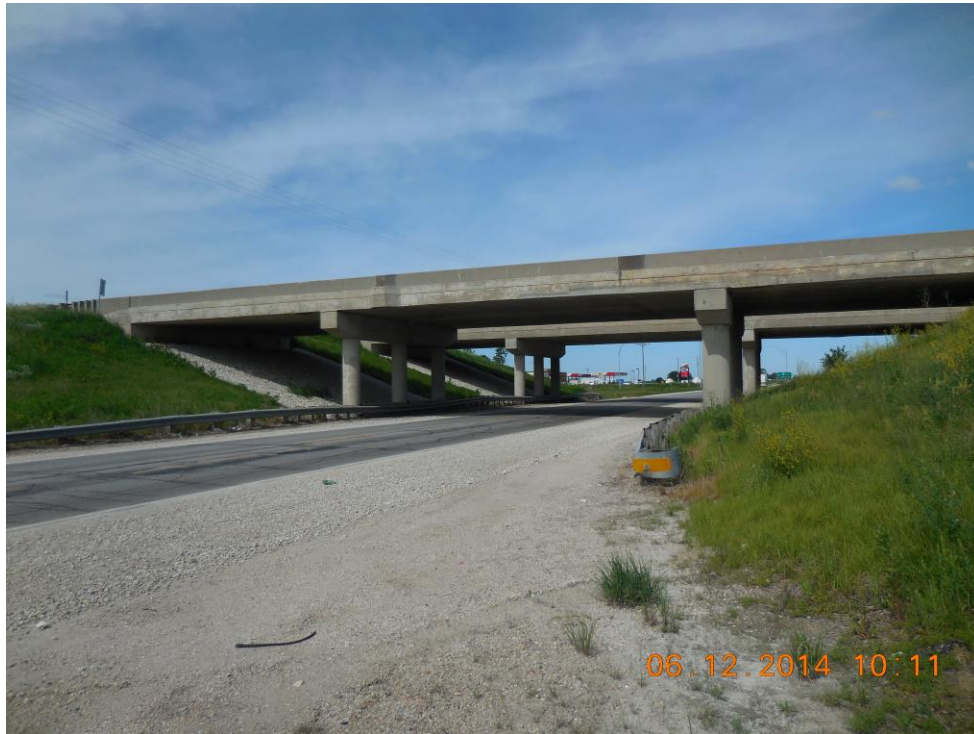
Figure 5.2.2. Continuous Concrete Slab Overpass

A number of cast-in-place concrete bridges remain on the State and U.S. highway system inventory in Iowa that could experience damage from an over height vehicle impact. These may include continuous concrete slab bridges, concrete frame or arch bridges, or concrete T-beam bridges. Figure 5.2.2 shows continuous concrete slab overpasses carrying I-35 over County Road D25, north of US 20 in Hamilton County.

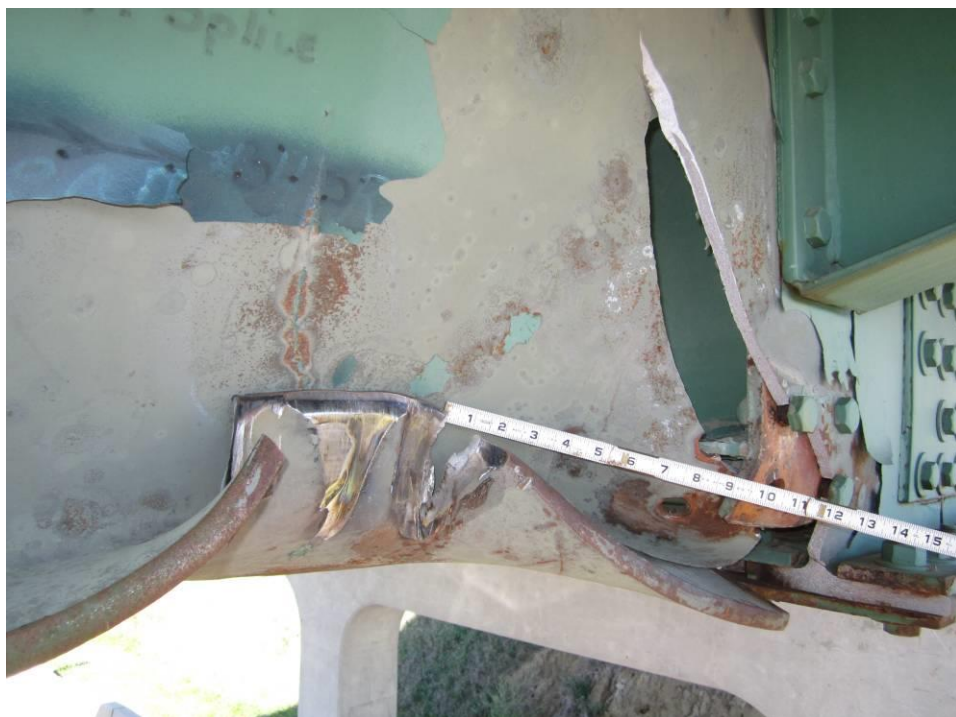
Photo No. 1 (East Exterior Beam Looking South)

The bottom flange was completely severed at the impact location and the web was cracked diagonally to within 7 inches of the top flange. See Photo No. 1 and No. 2. At the impact location the bottom flange was bent out of alignment approximately 7 ½ inches. One bolt was missing from the diaphragm connection. Clearance at the impact location was 15 ft 7 in.

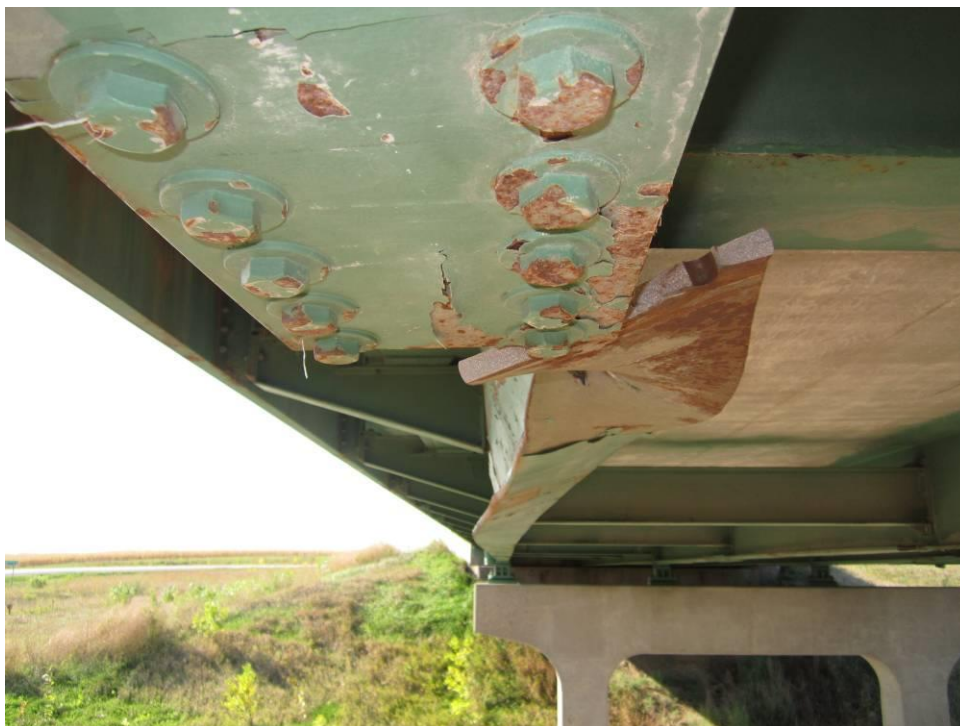
Photo No. 2 (East Exterior Beam Looking West)

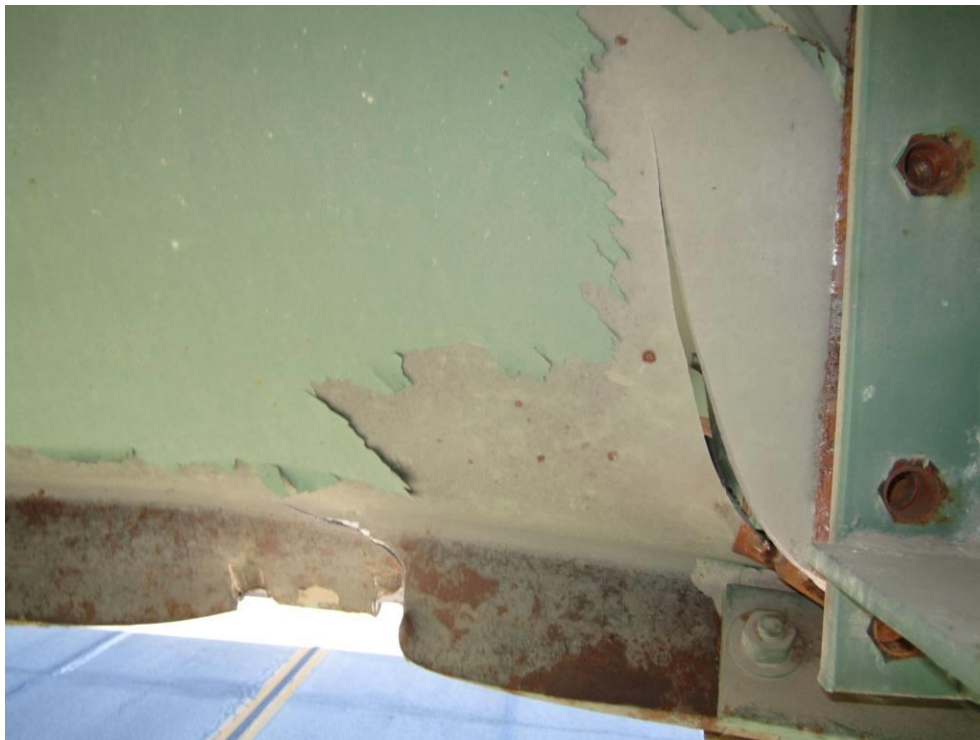
Photo No. 3 (East Interior Beam Looking West)

The east side of the bottom flange was cracked through to the web and bent out of alignment approximately 1'-2½" at the impact location. The web was cracked around the diaphragm and 9 of the 10 diaphragm bolts were broken. See photos No. 3 and No. 4. In addition, the diaphragm in Bay 2 was severely buckled. See photo No. 5.

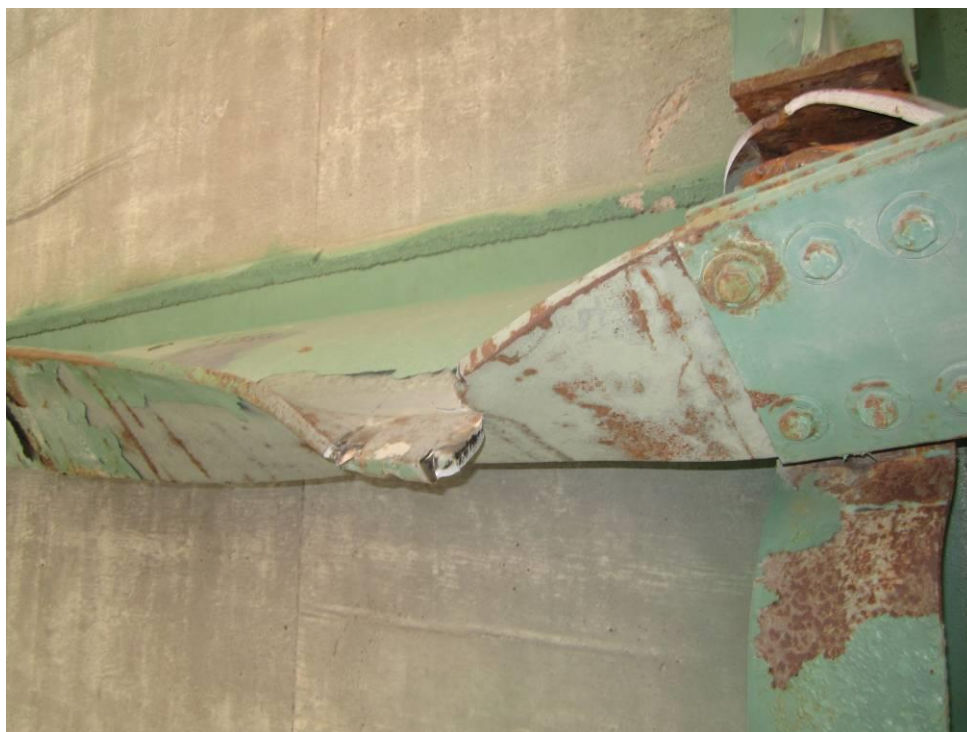
Photo No. 4 (East Interior Beam Looking Up From Below)

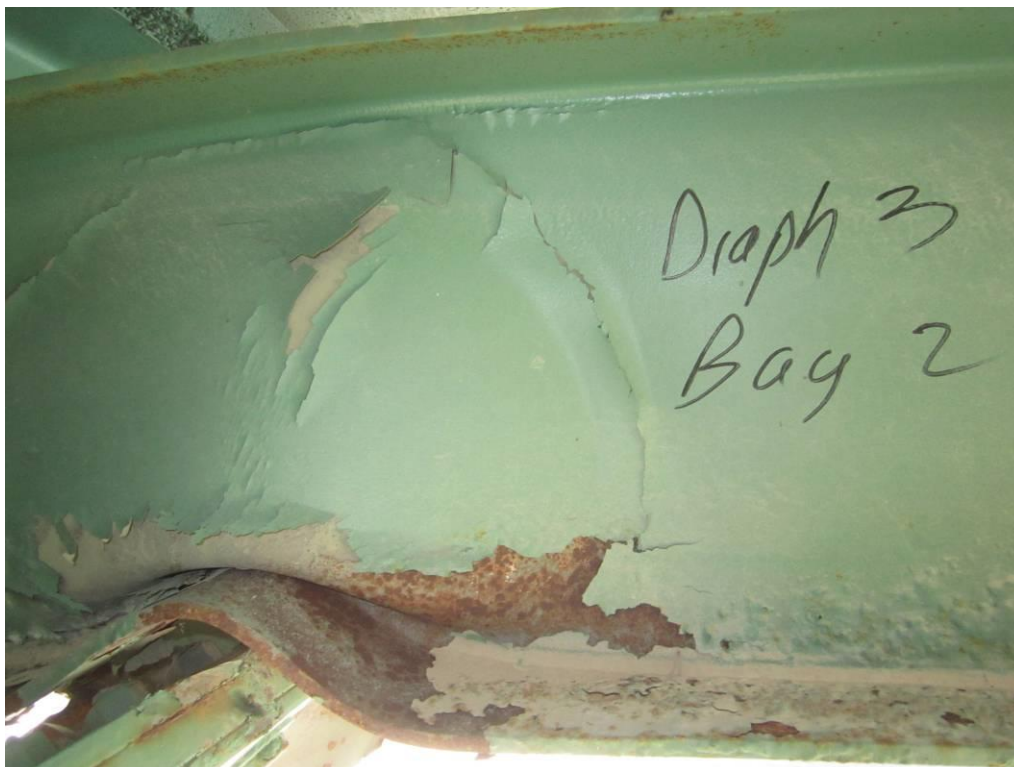
Photo No. 5 (Diaphragm 3, Bay 2, Looking South)

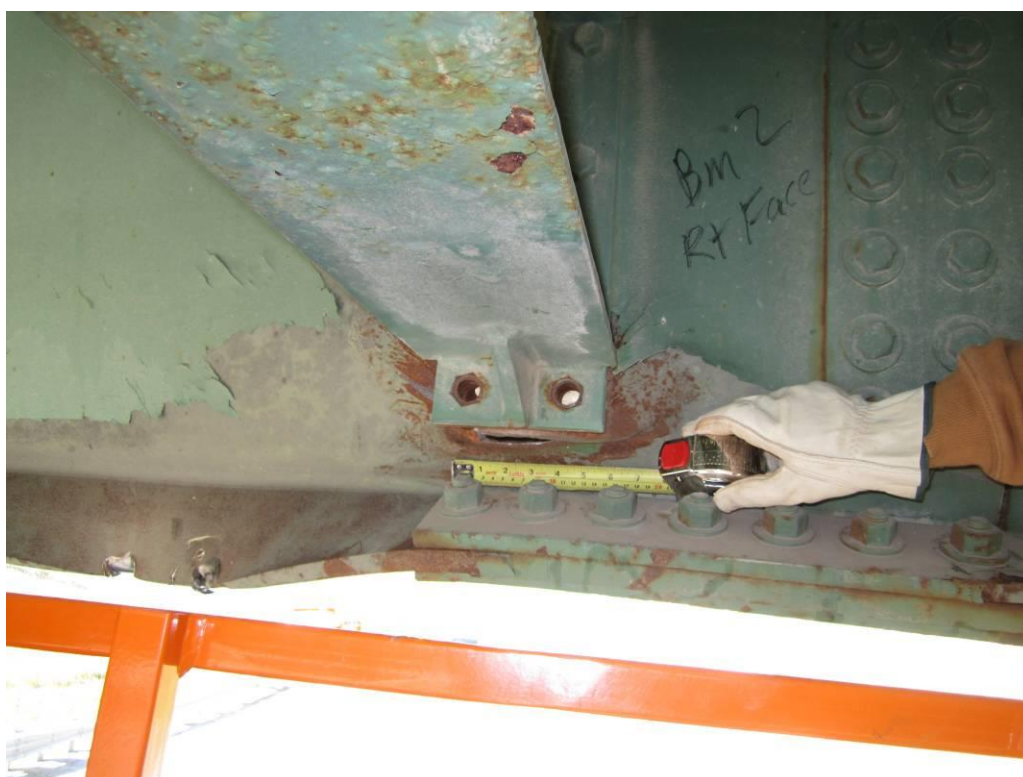
Photo No. 6 (West Interior Beam, Looking West)

The bottom flange had two gouges at the impact location and the flange was bent approximately 6¼" out of alignment at the impact location. There were two bolts missing at the diaphragm connection. See Photos No. 6 and No. 7.

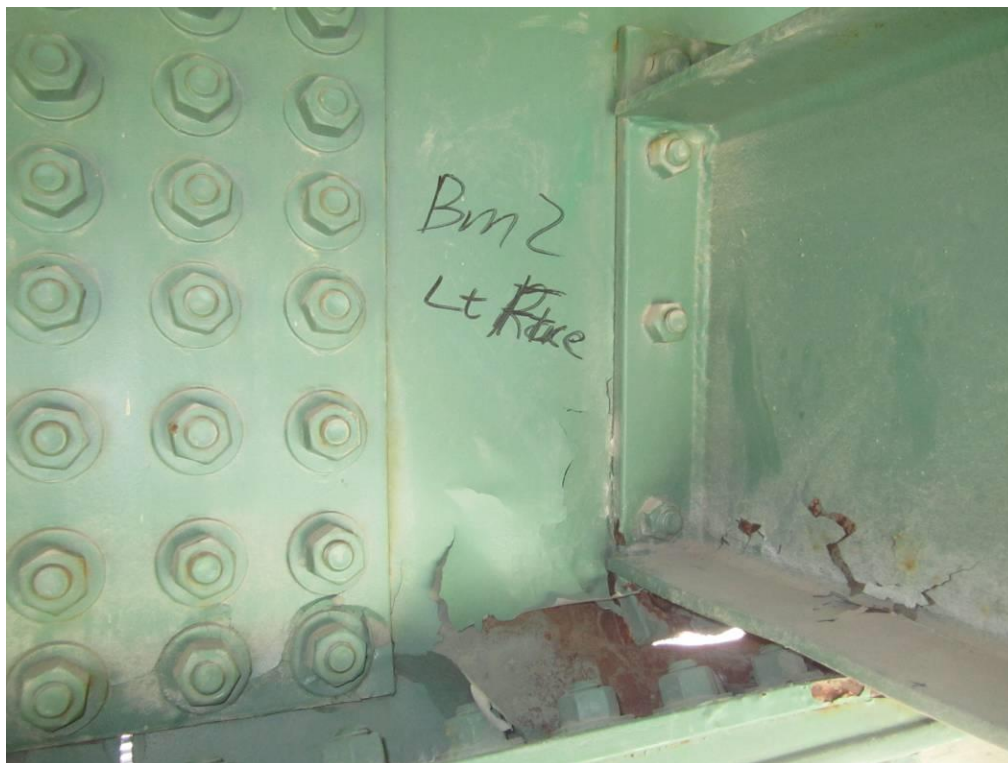
Photo No. 7 (West Interior Beam, Impact Location Looking East)

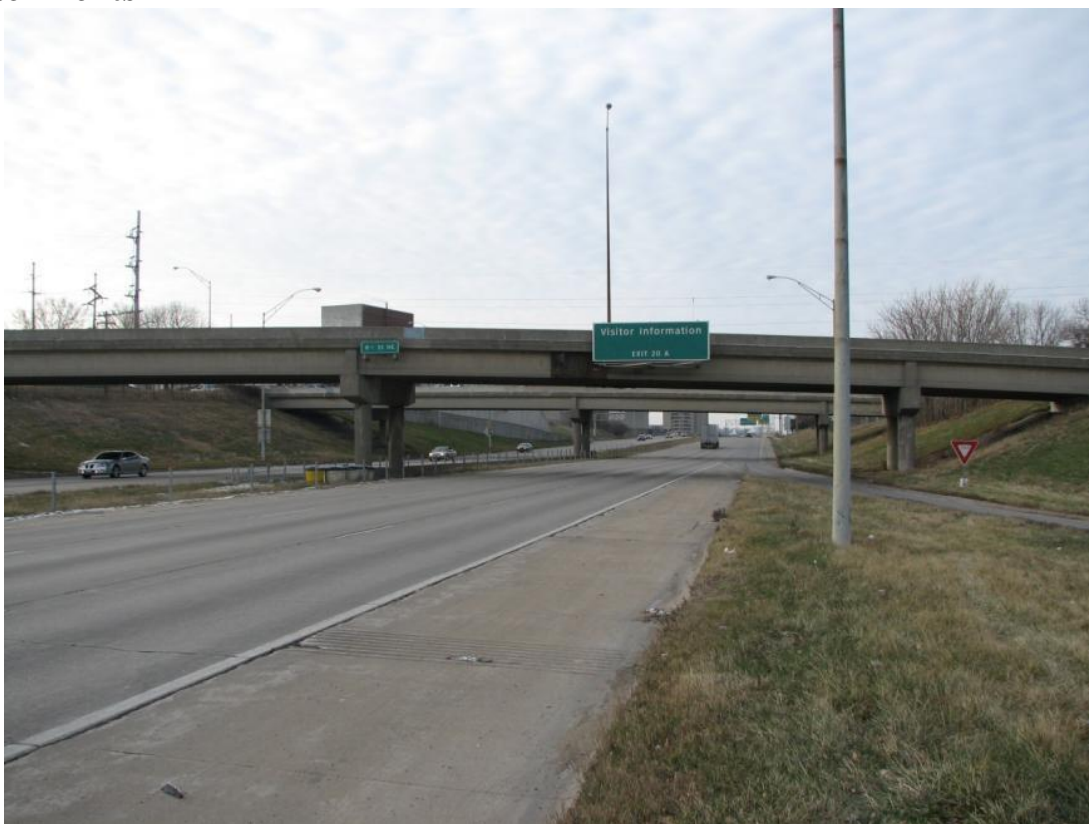
Photo 1: North Exterior Beam, North Side, Looking South.

The over height excavator struck the north and south exterior beams in span three over I-380 (Photos 1 and 6). The collision location for the north beam is approximately 38 feet west of pier no. 2 and the collision location for the south exterior beam is approximately 39 feet west of pier no. 2 directly below the light pole support.

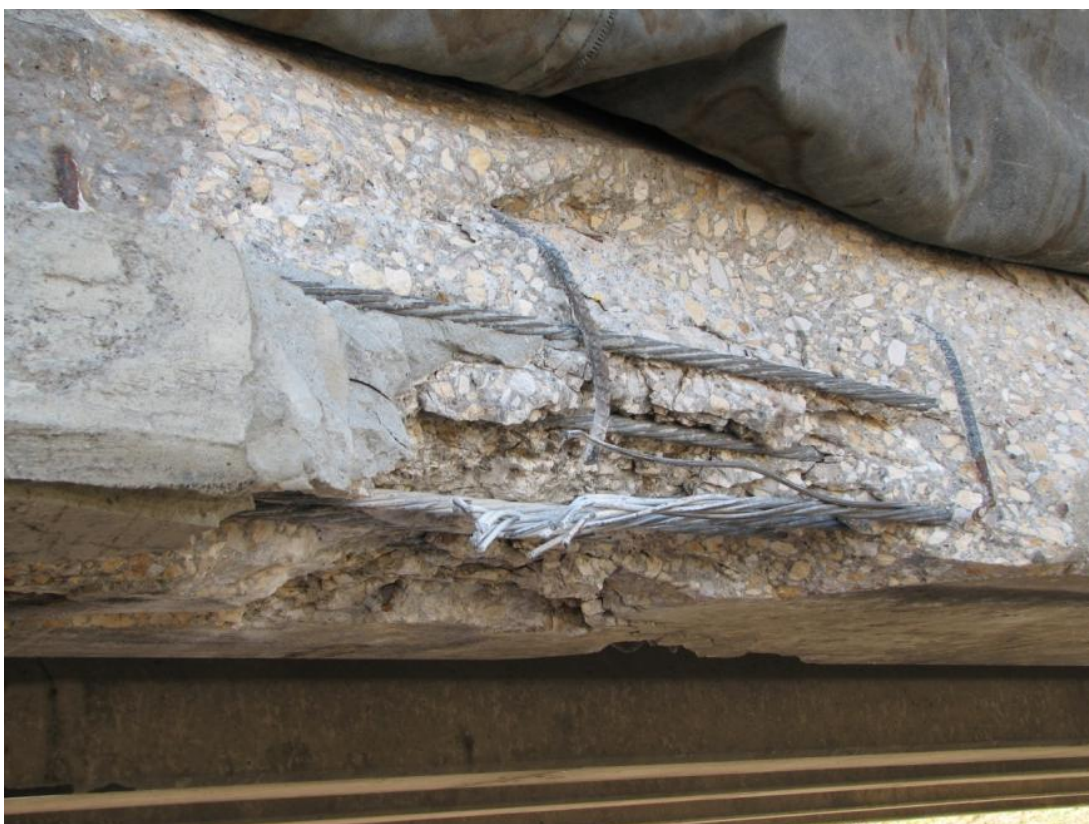
Photo 2: North Exterior Beam, North Side.

There are spalled and delaminated concrete areas for a distance of approximately five feet on the beam bottom flange. (Photo 2, 3, and 4). The bottom flange has one broken stirrup, two broken strands, and three exposed strands on the north side of the beam; two exposed stirrups and two exposed strands on the south side of the beam; and three exposed strands on the bottom of the beam (Photo 5). On the south side of the beam, there is a crack, approximately 4'-11 long, between the junction of the web and bottom flange fillet.

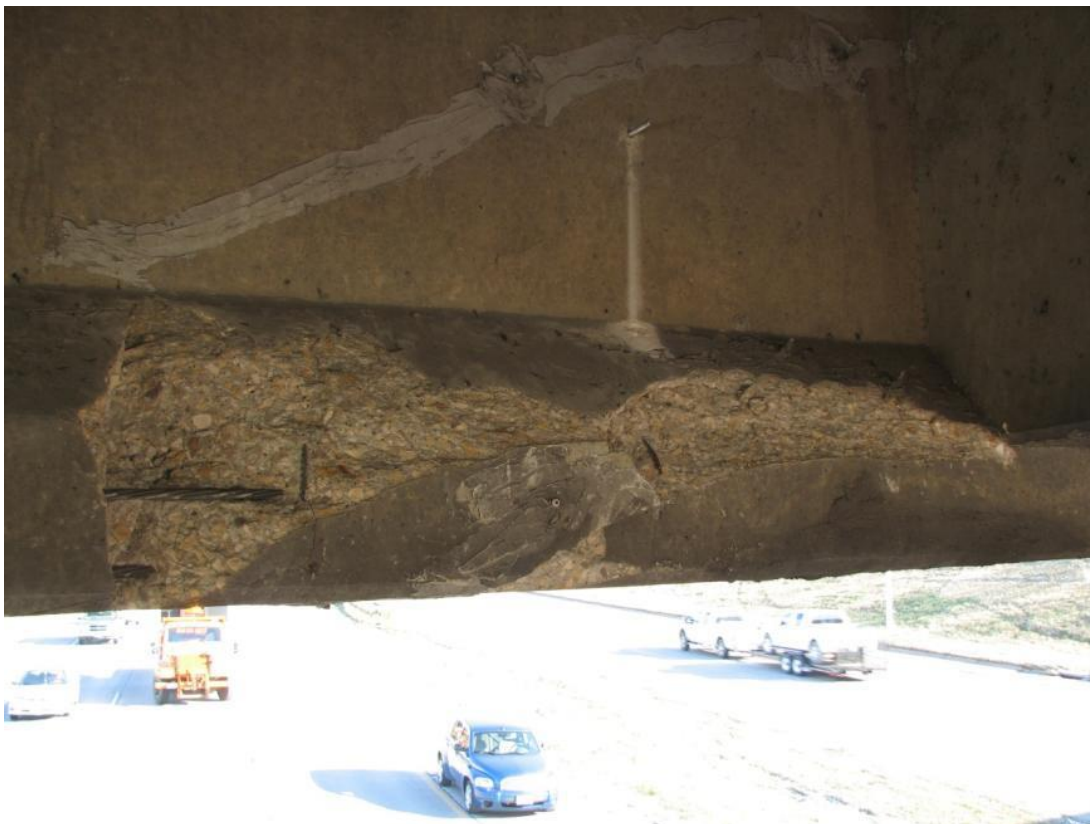
Photo 3: North Exterior Beam, South Side.

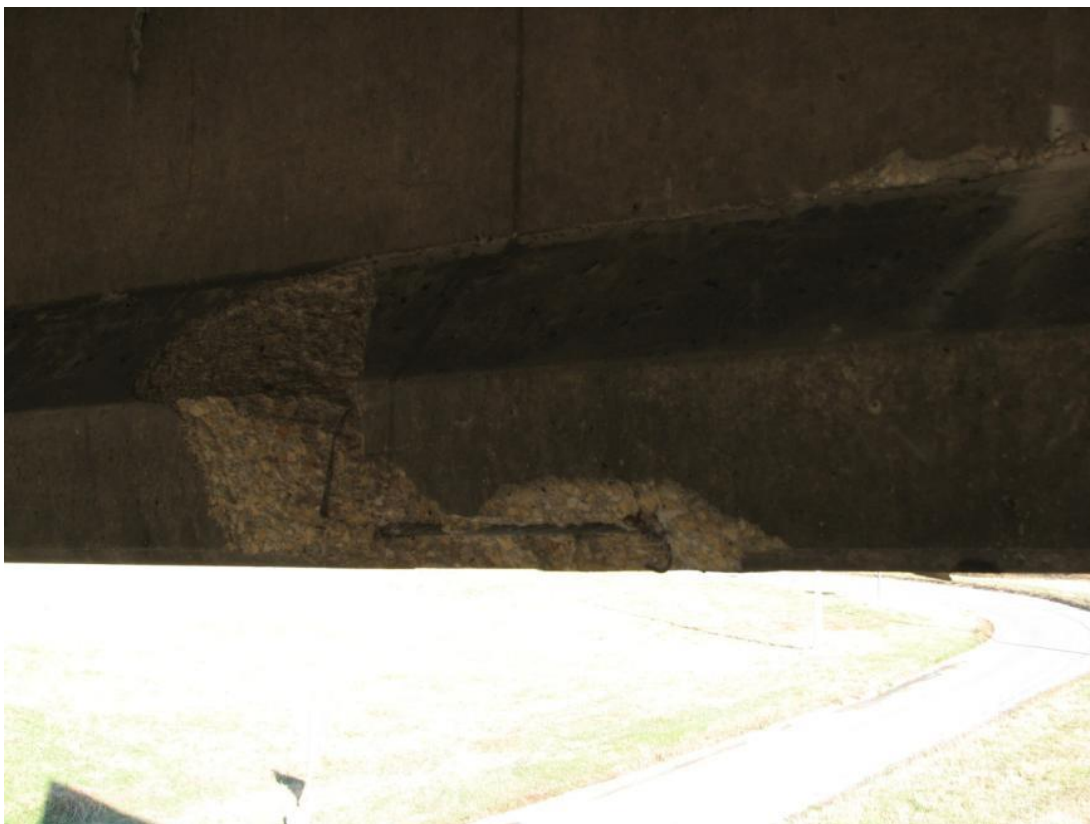
Photo 4: North Exterior Beam, South Side.

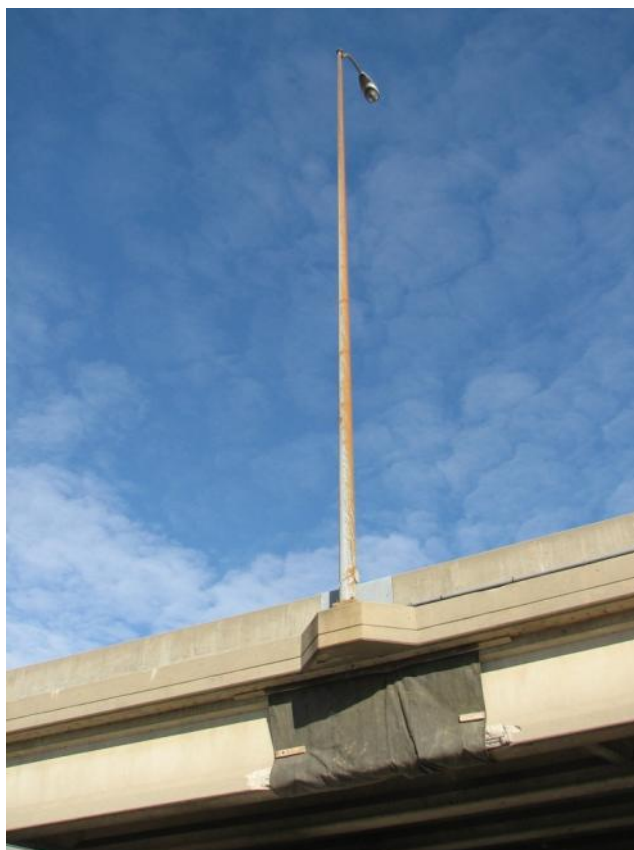
Photo 6: South Exterior Beam, South Side, Looking North.

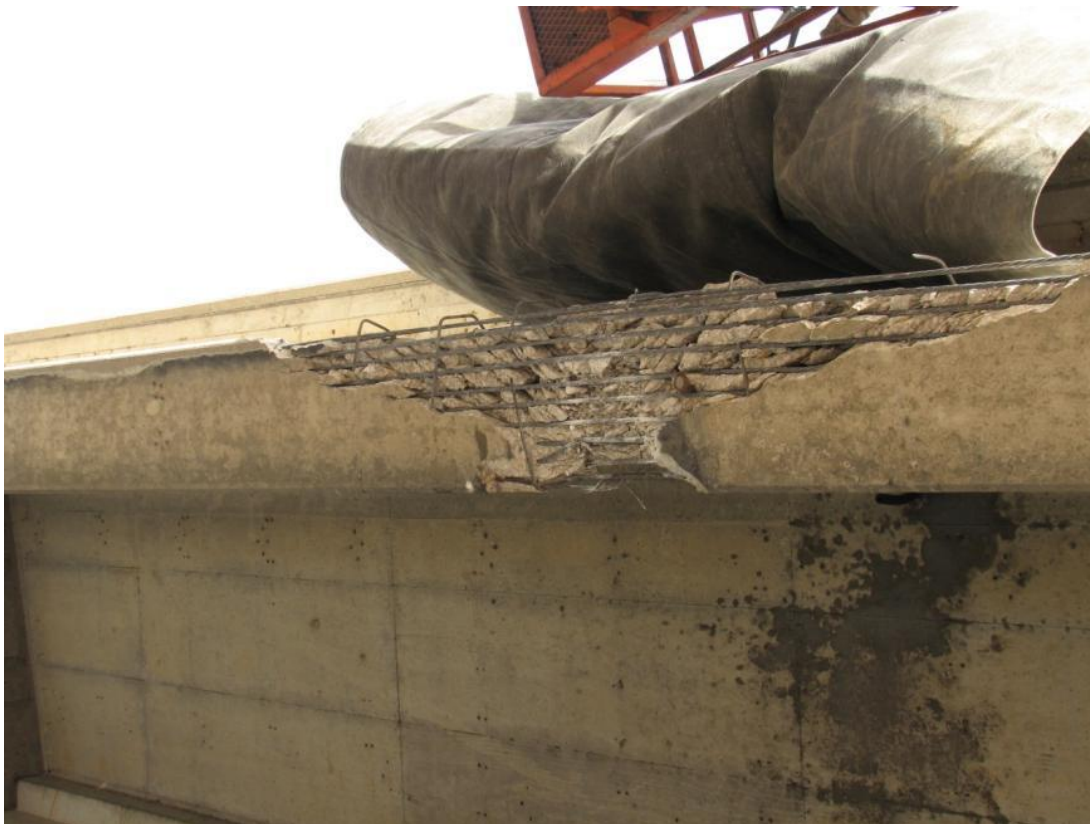
Photo 7: South Exterior Beam, Bottom Flange.

There are spalled and broken areas of the flange concrete throughout the impact location. The damage to the bottom flange extends for a distance of approximately three feet on the north side of the beam and eleven feet on the south side of the beam (Photo 7, 8, 9, 11, and 12). The bottom flange has six broken stirrups, three broken strands, and three vertical rows exposed strands. There are two spalled areas on the beam web, south side, approximately three feet wide by two feet high (Photo 10). There is also a hollow area on the south web face of the beam above the collision area. The area is approximately four and a half feet wide and extends to the top flange fillet.

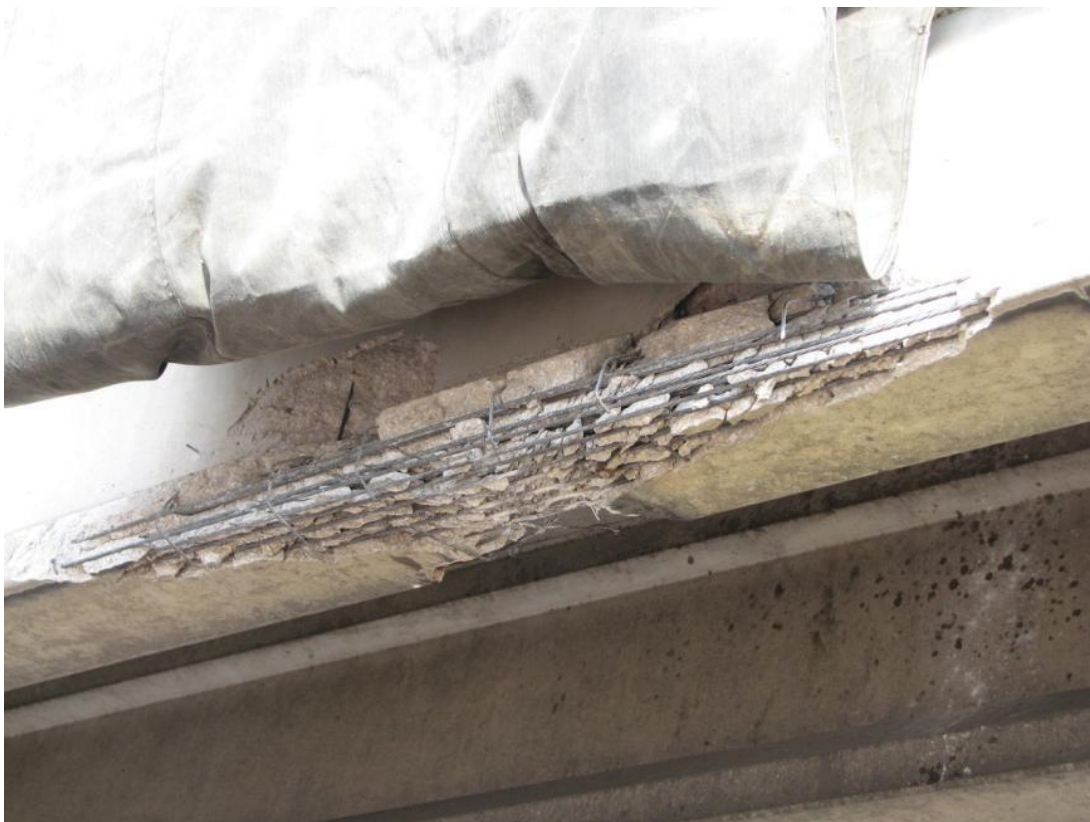
Photo 8: South Exterior Beam, South Side.

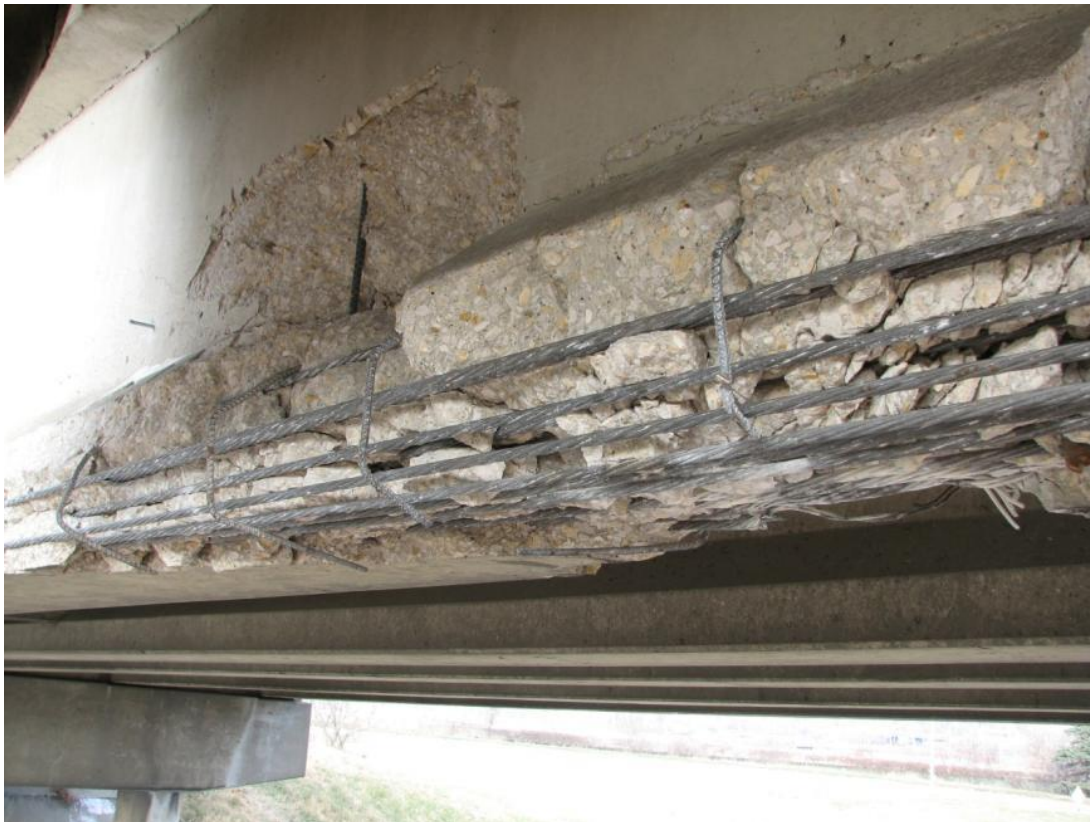
Photo 9: South Exterior Beam, South Side.

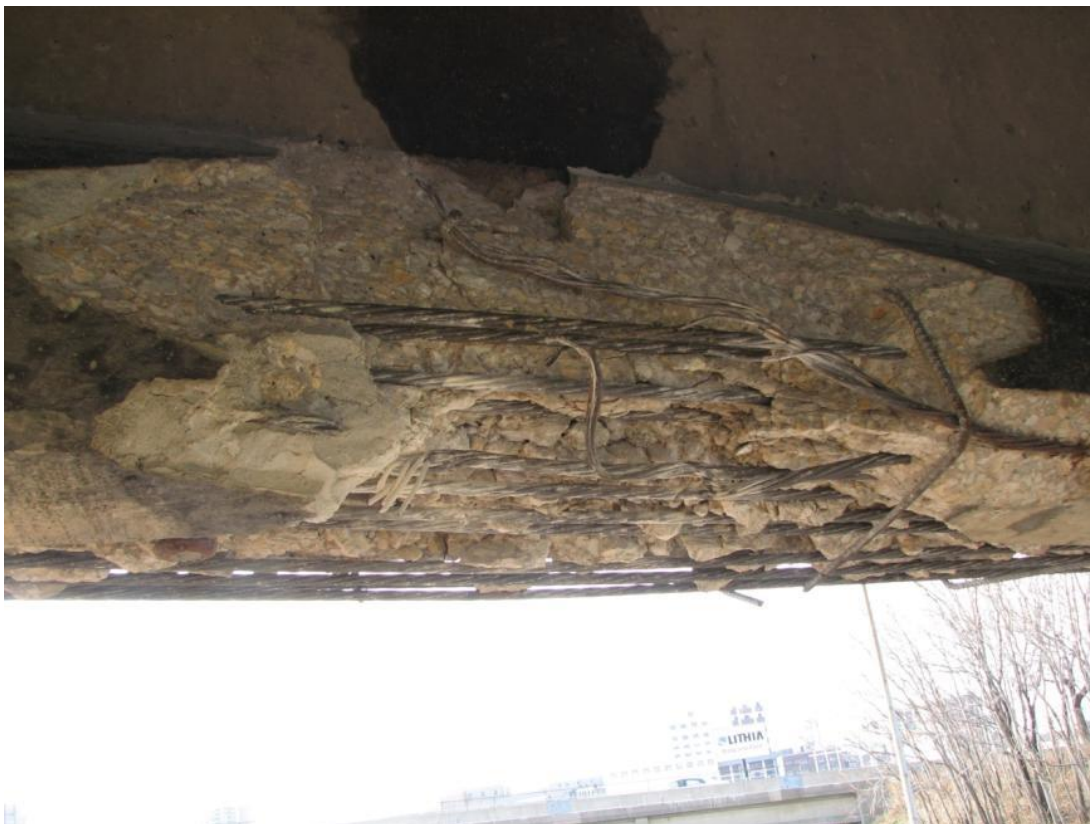
Photo 11: South Exterior Beam, North Side.

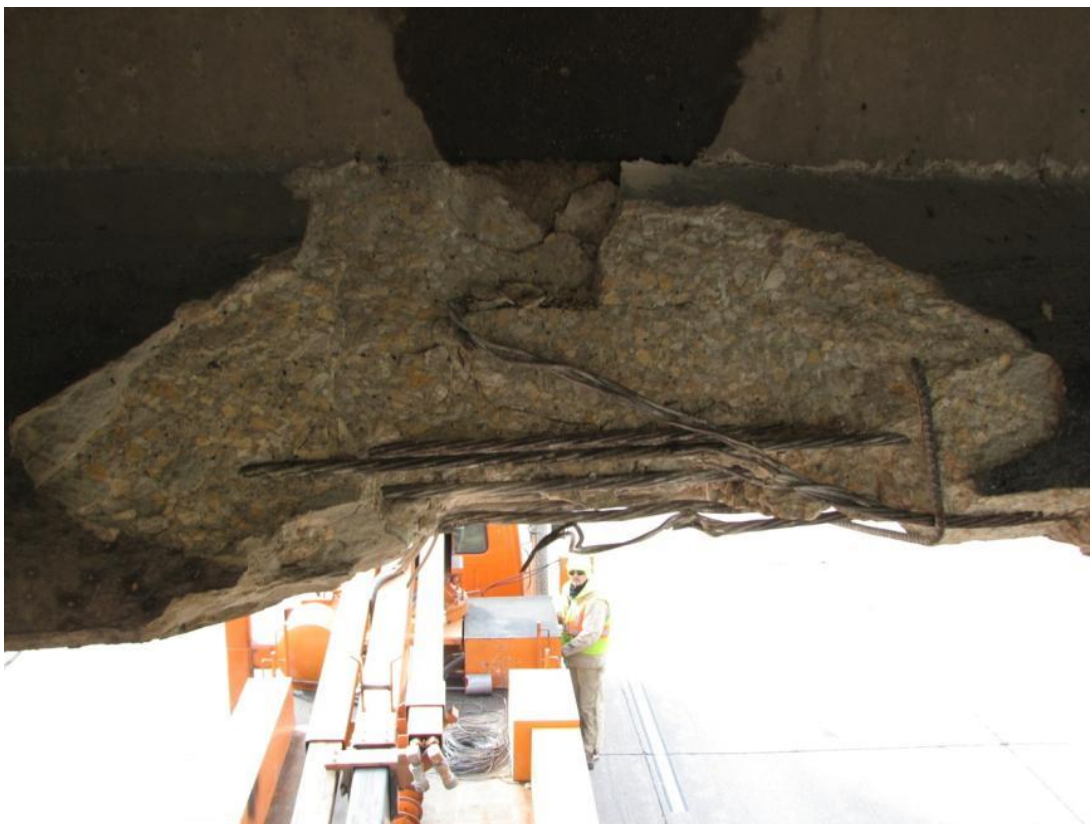
Photo 12: South Exterior Beam, North Side.

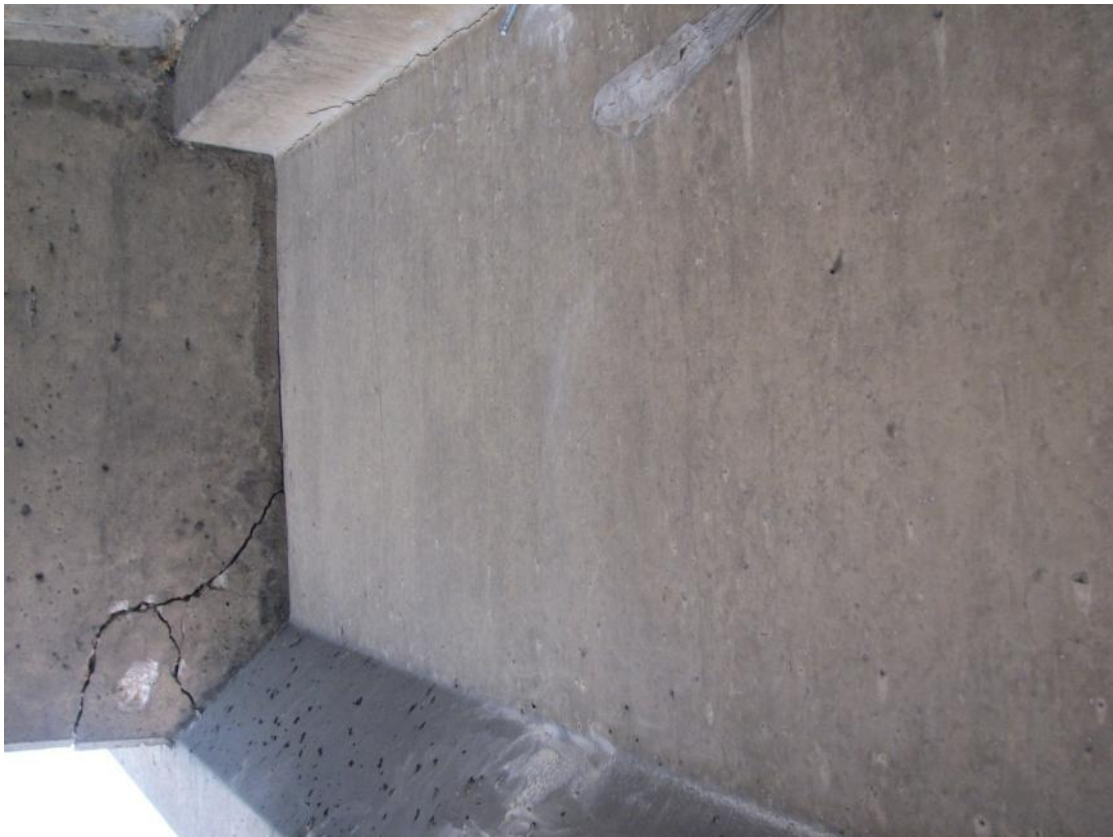
Photo 13: South Exterior Beam, North Side, Looking East.

The east intermediate concrete diaphragm between the south exterior beam and first interior beam is cracked (Photo 13, 14, and 15). The south exterior beam is also cracked along the junction of the web and top flange fillet from the pier no.2 diaphragm to the west undamaged intermediate concrete diaphragm.

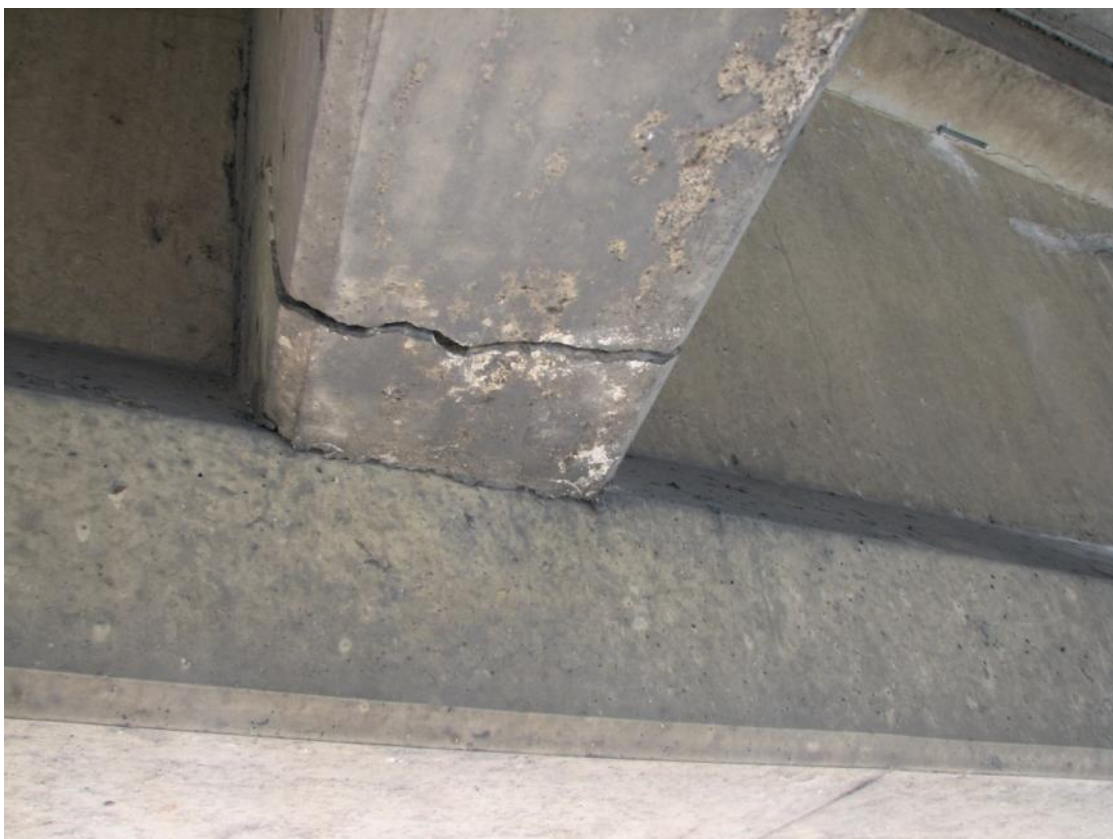
Photo 14: South Exterior Beam, North Side.

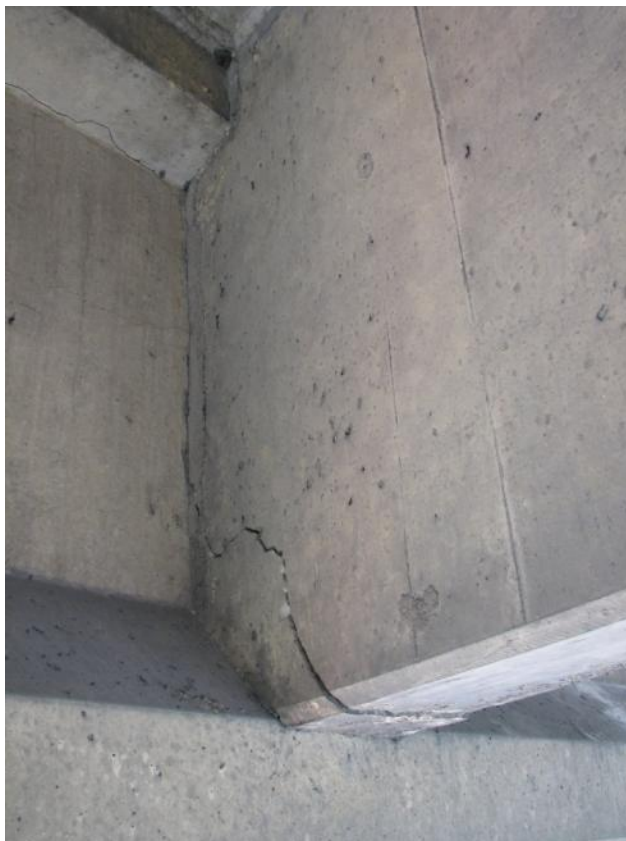
Photo 15: South Exterior Beam, North Side, Looking West.

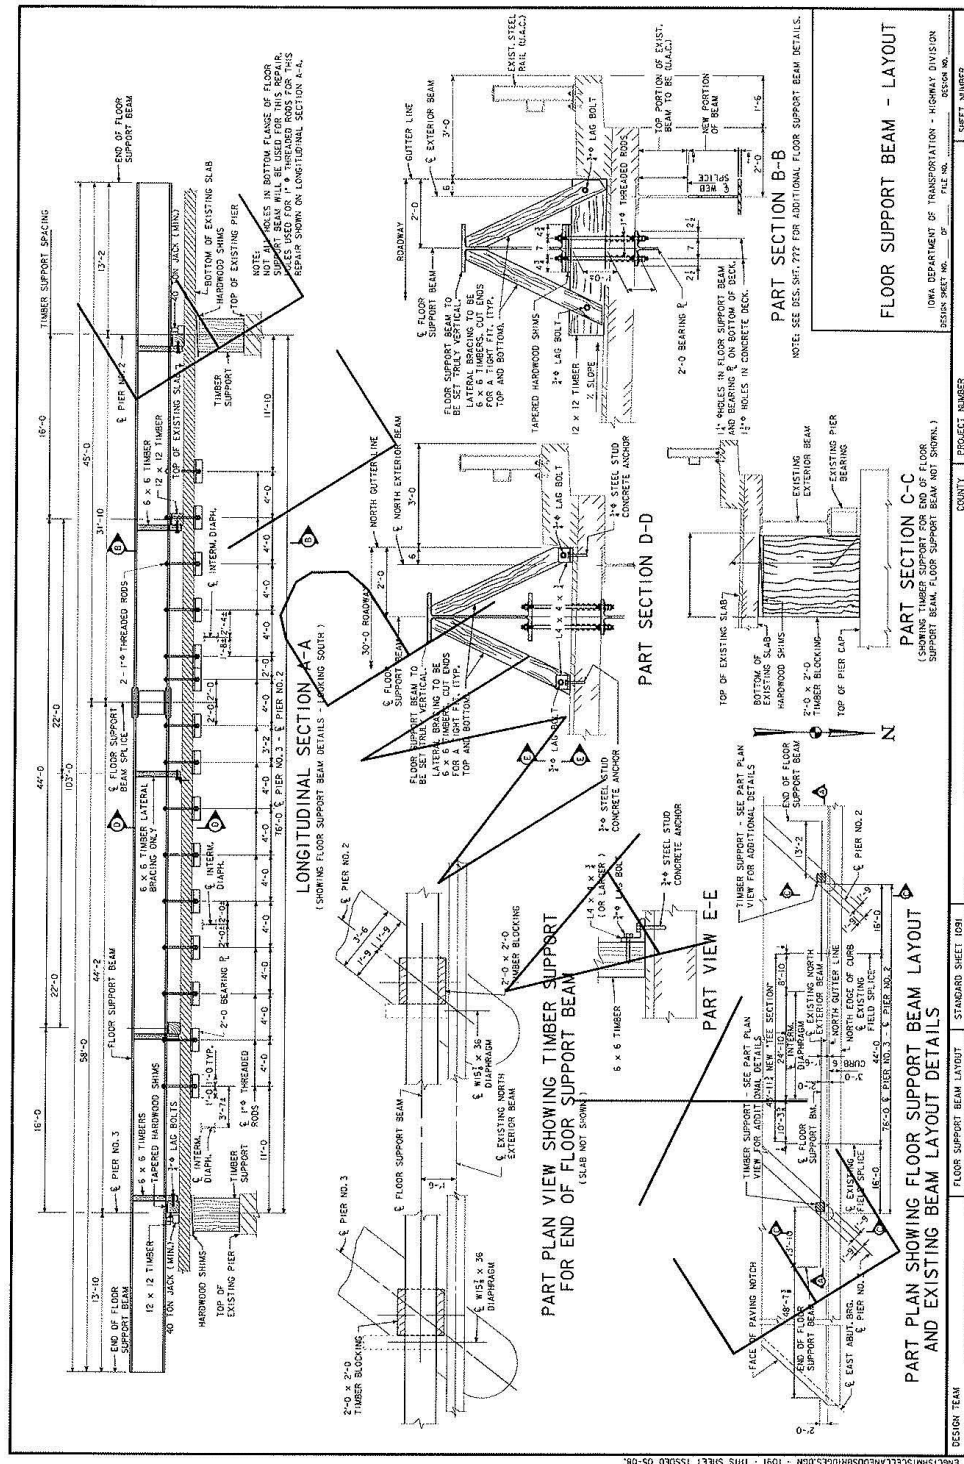
STRONG BACK AND SUPPORT BEAM DETAILS FOR DAMAGED BRIDGES
